VERIFICATION REQUIREMENTS FOR COVER SYSTEMS

Technical Guidance for
Developers,
Landowners and
Consultants

**Yorkshire and Lincolnshire
Pollution Advisory Group**

Version 4.1 – June 2021

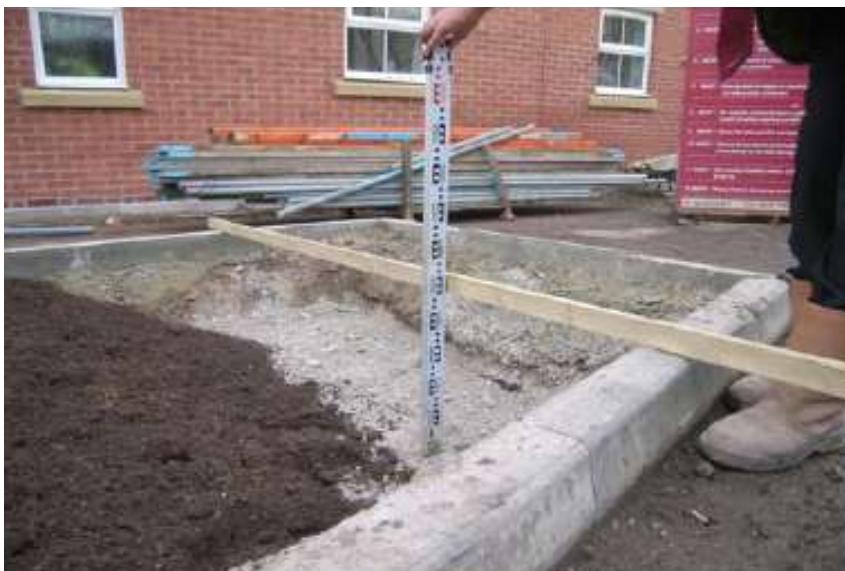
Photograph 1:
Depth check of inert cover within area of public open space.
Physical break layer and topsoil visible.

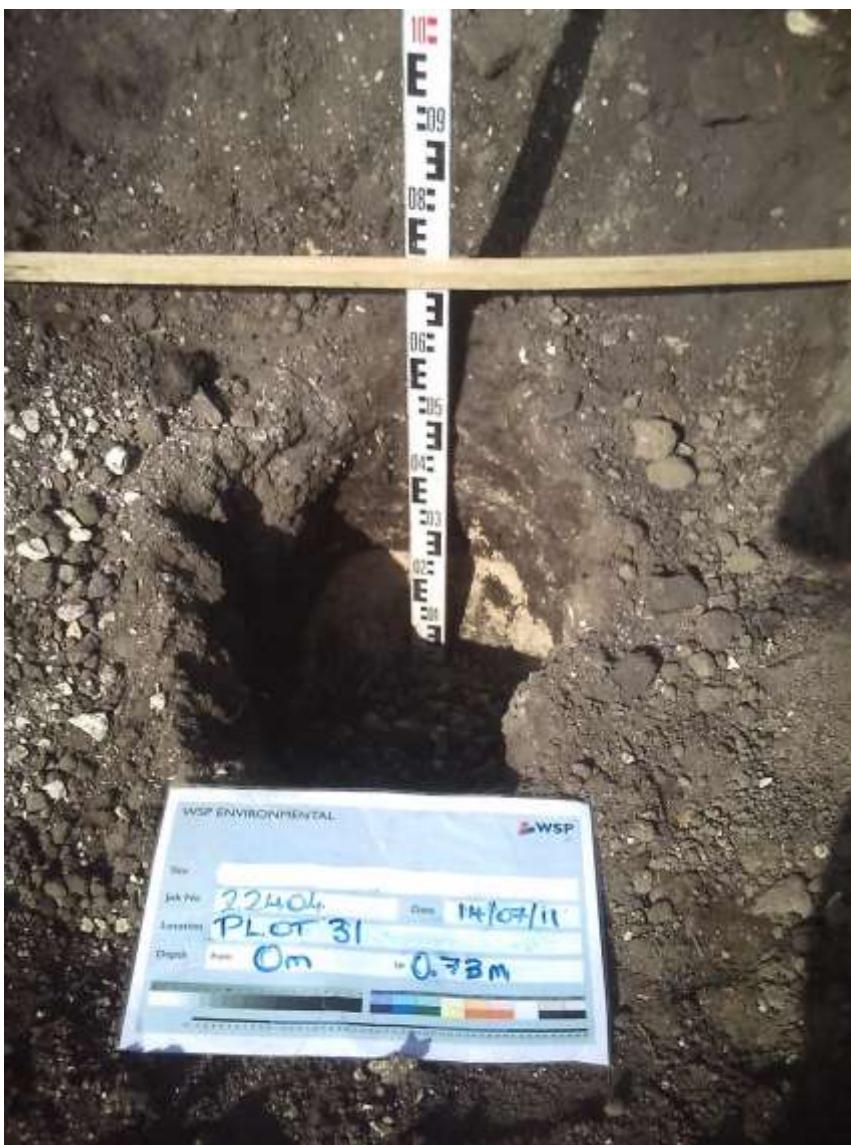
Photograph 2:
Depth check of inert cover with Site & Location Information Board.

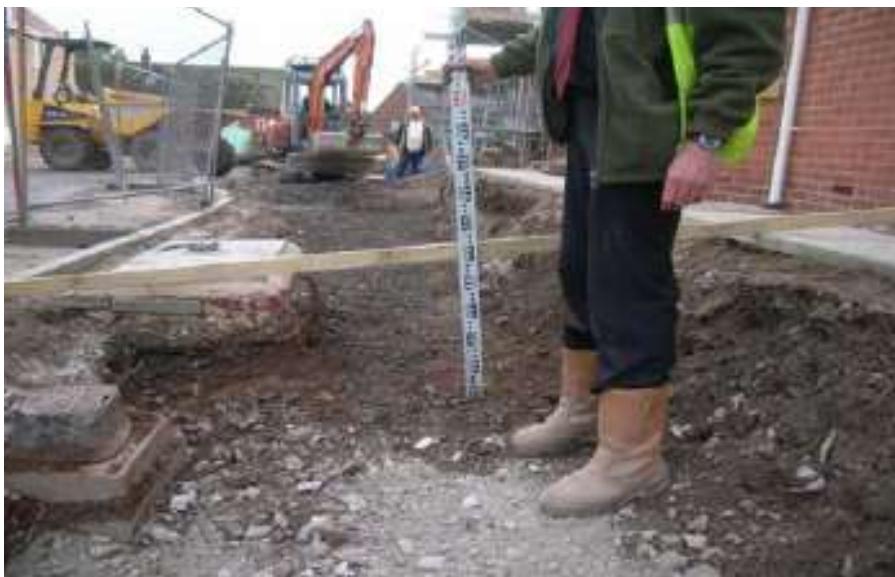
Photograph 3:
Depth check of inert
cover within areas of
front gardens.

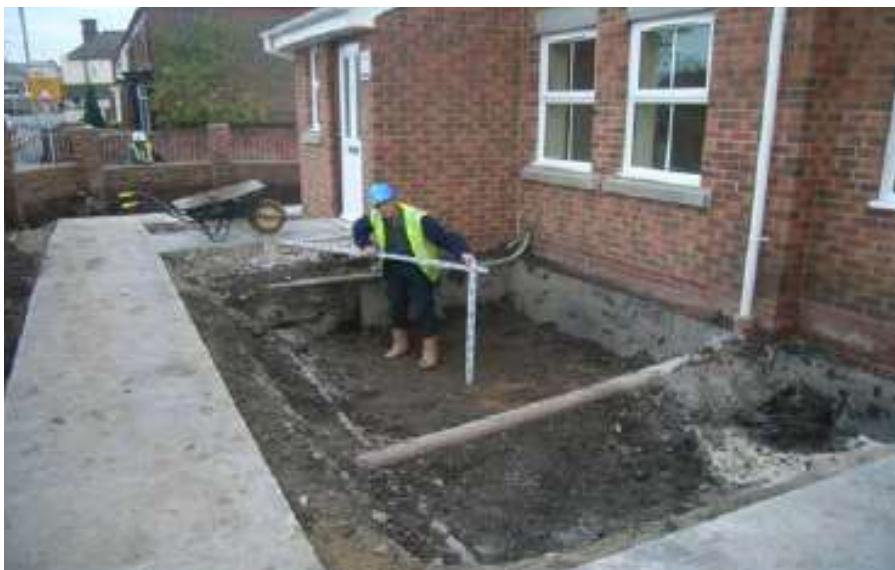
Photograph 4:
Depth check of inert
cover within areas of
front gardens.

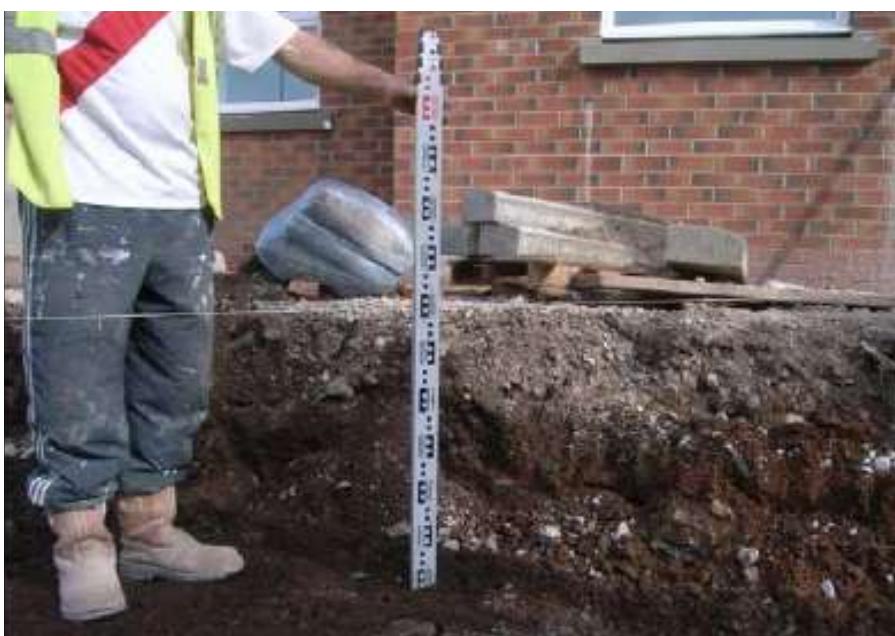
Photograph 5:
Depth check of inert
cover within rear
gardens. Taut string
line spans across
excavation.

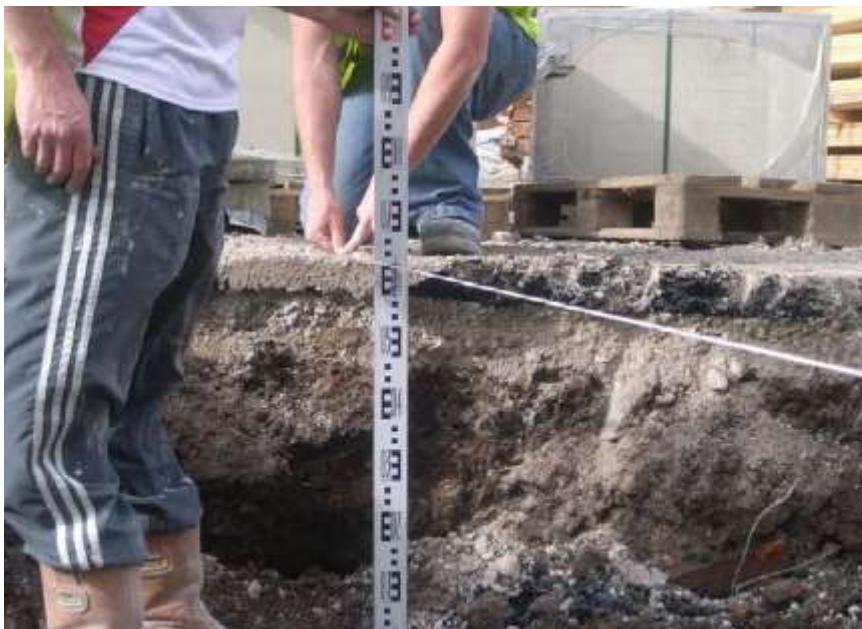
Photograph 6:
Depth check of inert
cover within rear
gardens. Taut string
line spans across
excavation.

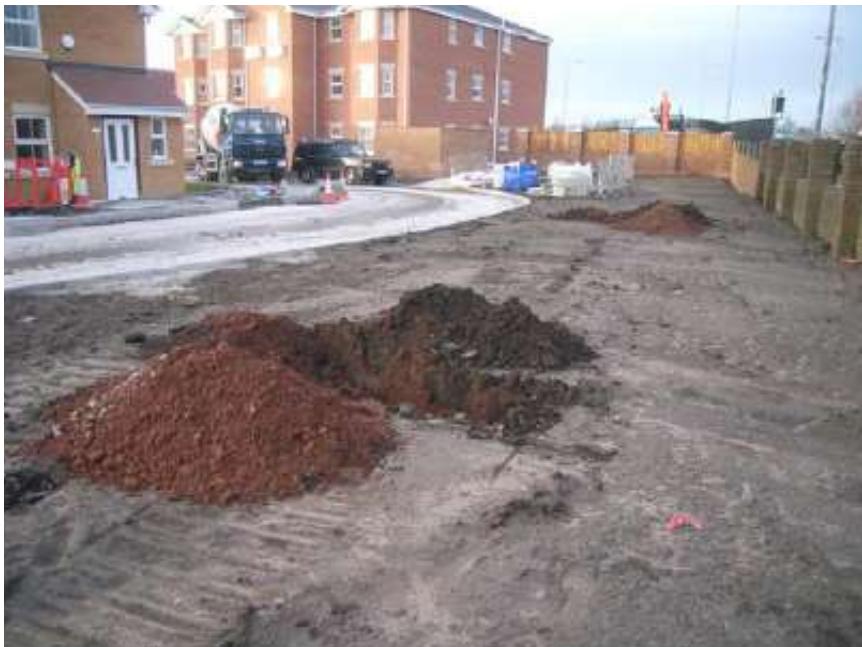
Photograph 7:
Shows the spatial
location of the
verification pit.

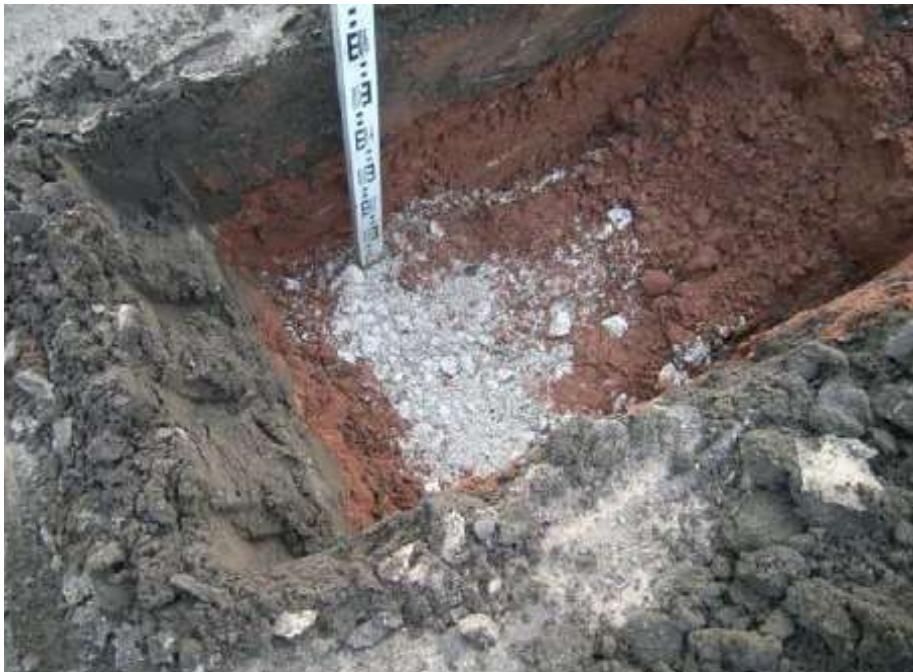
Photograph 8:
Excavation within public open space and verification pit showing the presence of a remediation break layer at the base, a crushed sandstone inert fill overlain by topsoil.

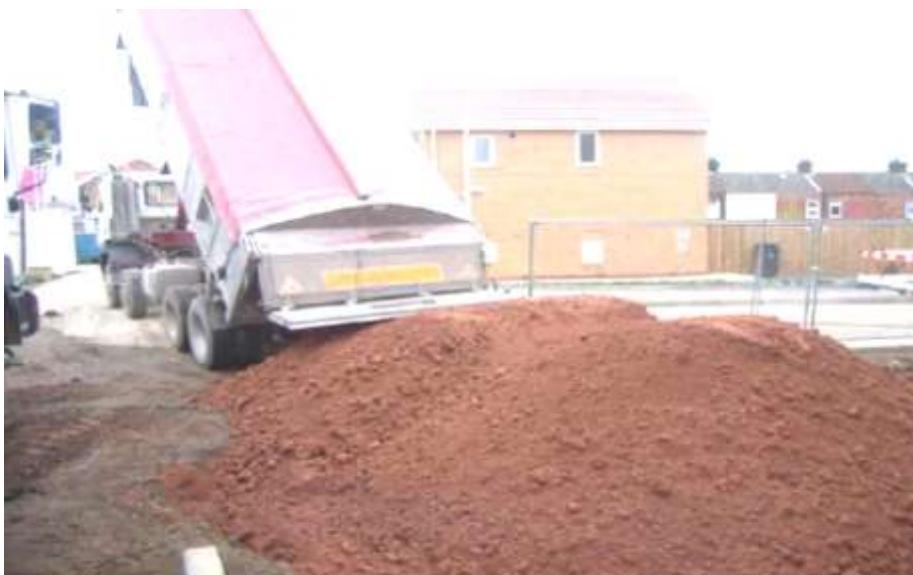
Photograph 9:
Inert crushed sandstone being delivered. The spatial area of the remediation can be observed from these photographs (old terrace housing).

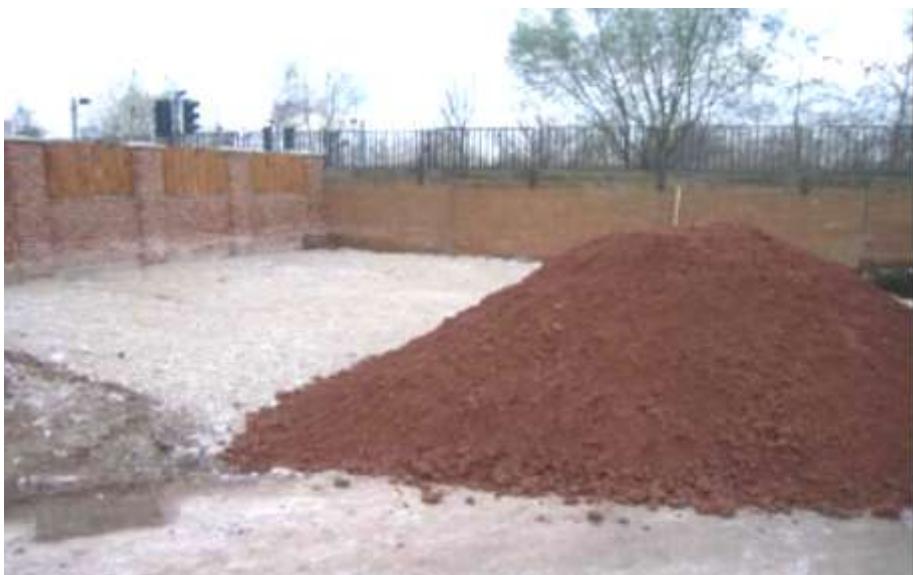
Photograph 10: Inert crushed sandstone being delivered with visible remediation break layer. The spatial area of the remediation can be observed from these photographs (traffic lights).

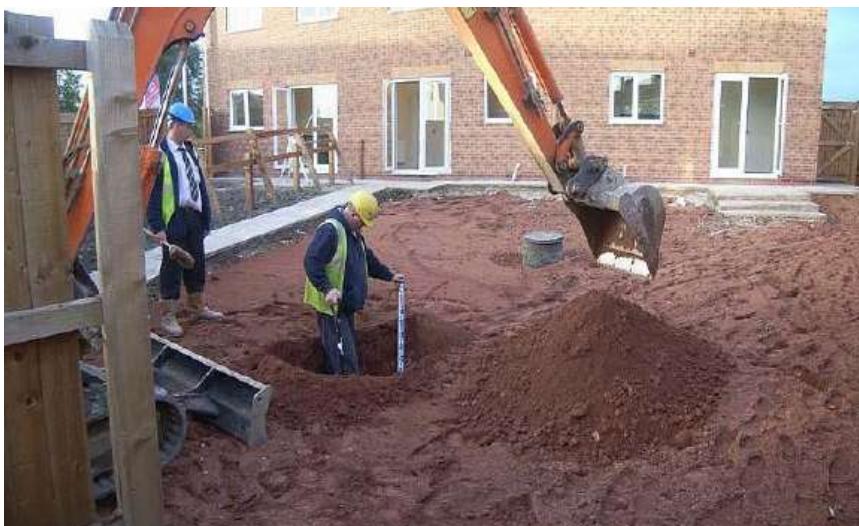
Photograph 11:
Shows the remediation of the rear garden, with a significant depth (1.0m) of inert cover. This photograph has been stitched to form a panoramic photograph and hence there is slight distortion

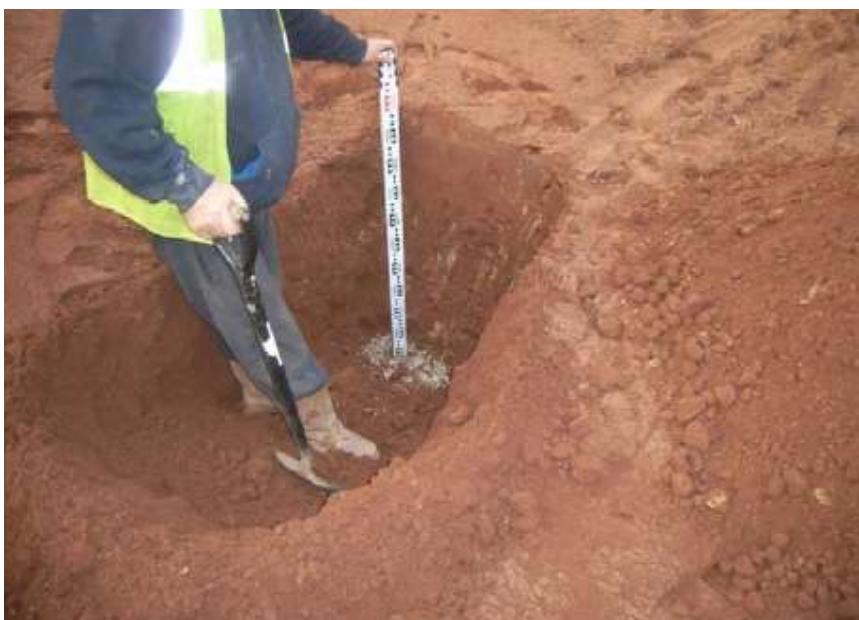
Photograph 12:
Shows the remediation of the rear garden, with a significant depth (1.0m) of inert cover. Remediation break layer visible at the base of the excavation.
