Scorton

CONSERVATION AREA APPRAISAL AND MANAGEMENT PLAN

Adopted 28 April 2015

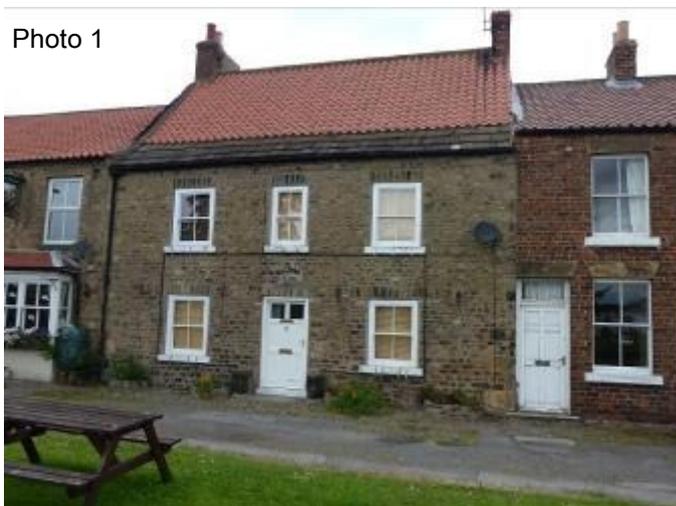
Photo 1

The older properties of the village show all the evidence of the local vernacular style and most date from the mid 18th Century. The main group of older properties in the village are on the north side of the village green. Virginia House (photo 1) is a good example of a two storey, three bay, house constructed of coursed rubble stone. All openings have flat brick arches and stone cills with timber vertical sashes subdivided into two over two in the Victorian style. The roof is steeply

pitched and covered in pantiles with a stone eaves course, shaped kneelers and brick end stacks.

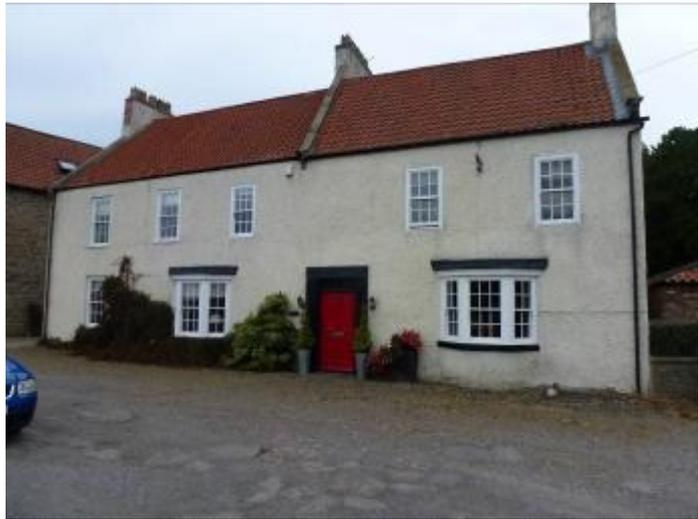
Photo 2

Mulberry House (photo 2) is of a similar date and was the former Royal Hotel. It is of a two sections of a similar scale. This property is roughcast rendered, which along with stone is the main walling material in the village. The building has a similarly steeply pitched roof. The gables on this property are visible and a simple side hung casement window gives evidence of an attic storey. The building has

vertical emphasis to the windows but in this case has retained the older form of sliding sash timber windows divided into six over six. This property has two small bay windows echoing the former public house use. The roof is covered in pantiles with shaped kneelers and ashlar copings. There are end chimney stacks on each section. This particular property has no decorative detail visible for the openings, but other roughcast rendered properties of a similar date such as Mill House incorporate ashlar surrounds with keystones to openings. Unfortunately the latter has had a replacement roof at some stage. It would formerly have been pantiles but the existing profiled concrete tiles do nothing to enhance the building.

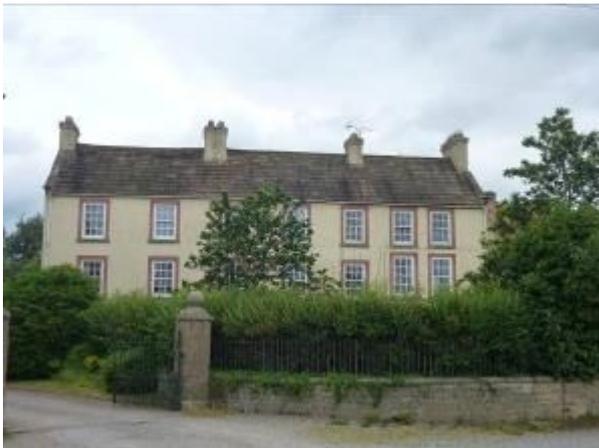
Photo 3

School House (photo 3) is one of the few full three storey properties in the village and the only property with a stone flagged roof, a

material which is more commonly found to the west of Scorton. The stone flagged roof has ashlar shaped kneelers and copings. An element that is contrary to the general character of the village is the large external stepped chimney stack to the east gable (photo 4). This is one of four chimneys on the property the others having the more traditional internal stacks. This property has one of the few ornate door surrounds in the form of an open pediment on brackets whereas others tend to have a simple surround with fanlights. This property is larger in scale than commonly found in Scorton with three storeys and seven bays. Each storey has a full height window with ashlar surrounds and vertical sliding sashes with glazing bars. This property is again slightly different to the character of the rest of

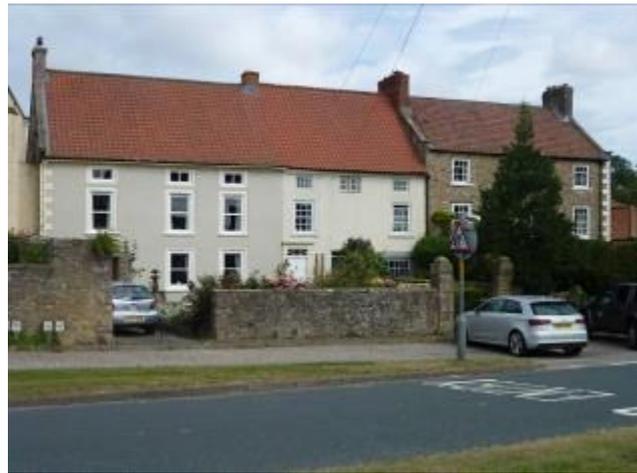
Photo 5

the village in that the usual dominance of solid over void has been reduced thanks in part to the full height window on the third storey. The visual impression of this property is that it is over windowed. The neighbouring properties of Swale View and Greencroft (photo 5) being slightly less tall have utilized a small window to light the attic level and the balance of solid over void has been re-established.

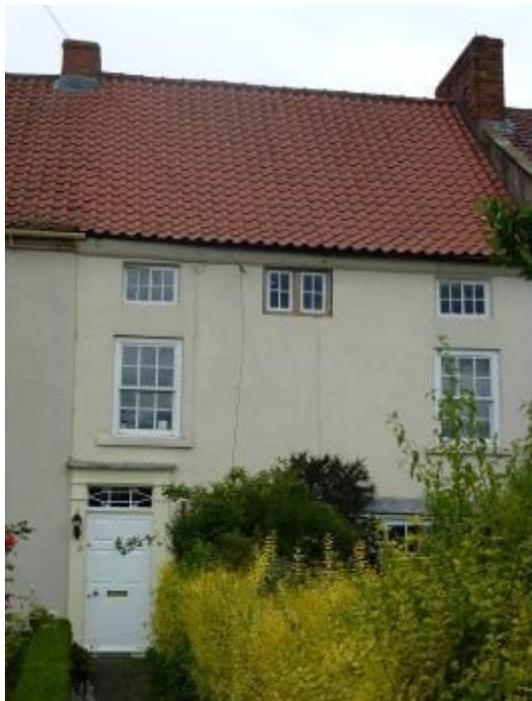
Photo 6

The pattern of fenestration on Greencroft (photo 6) with glazing bars is likely to be closer to the original fenestration pattern.

Greencroft has a good example of a mullioned window, historically the original form of window for the locality. There is also evidence of a similar mullioned window in the gable of Swale View. Strangely on this pair of properties Swale View has chamfered ashlar surrounds and chamfered rusticated quoins but its attached neighbour of a similar date has neither. Holly House is another full three storey building. Visually the fewer bays and smaller scale of the windows follows the traditional solid to void relationship found elsewhere in the village.

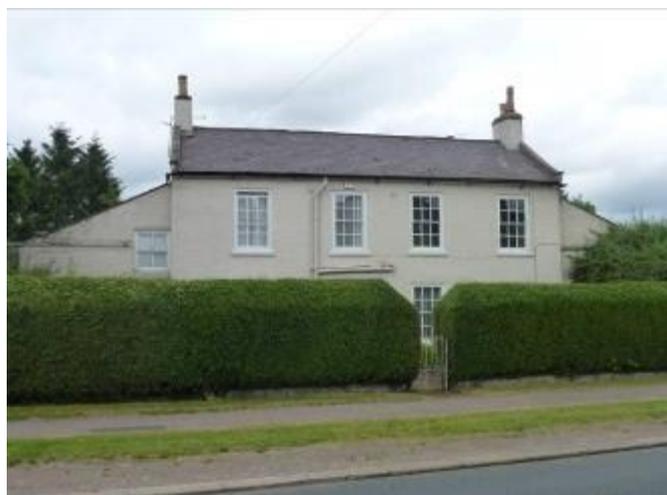
Photo 7

Moving away from the central Village Green location onto Hospital Road is The Lodge (photo 7), a detached house slightly separate from the main group of older properties on the

village green. It is a similar scale to the others but unusually is flanked on either gable by lean-to pavilions. The finish is roughcast brick and unusually in the village the roof is Welsh slate. Welsh slate is only found on about 18% of properties in the village preference over the centuries has obviously been to continue to use the local clay pantiles. The Lodge does feature ashlar copings, shaped kneelers and end stacks all common amongst the

older properties of the village. The windows are vertical sliding sash with glazing bars as found elsewhere in the village but the decorative surrounds are limited to a projecting cill and a door case.

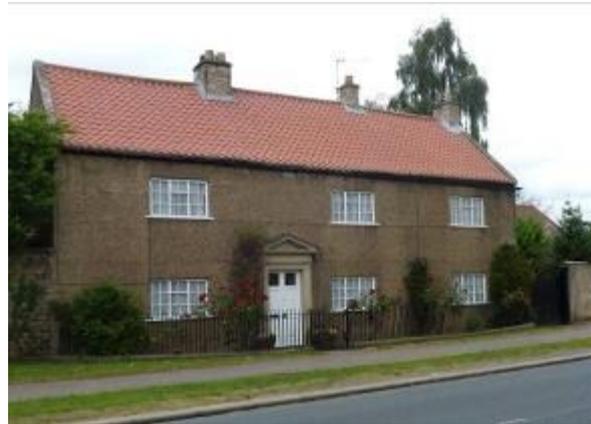
Photo 8

Rose Cottage (photo 8) another detached property on Hospital Road of a similar scale to the other older properties, is roughcast with a pantile roof but the windows have been altered at some point producing a modern fenestration pattern. It has a particularly detailed door surround of pedimented stone architrave (photo 9). The roof has the stone copings and kneelers common to the older properties of the village but the property lacks the end stacks. Being detached and set apart

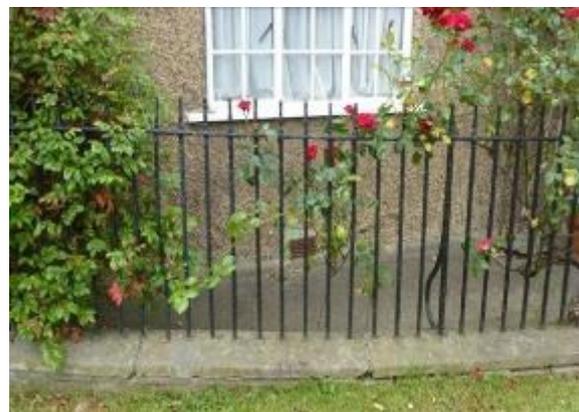
Photo 10

Lodge and Rose Cottage, have features that provide a setting namely the stone plinth and railings and boundary walls (photo 10).

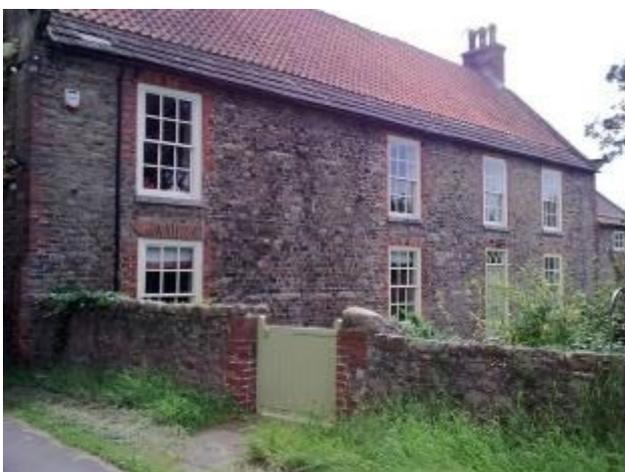
Photo 11

To the south of the Village Green the mid 18th Century properties are less numerous and they stand apart from to each other which acts to dilute the impact of their historic character. The Manor House (photo 11) is particularly set apart, lying behind what is effectively a more private part of the Green. In design terms its solid simple form echoes the character of the other older properties of the village, a two story coursed rubble building with brick

quoins and flat-arched opening surrounds. The pantile roof has a stone eaves

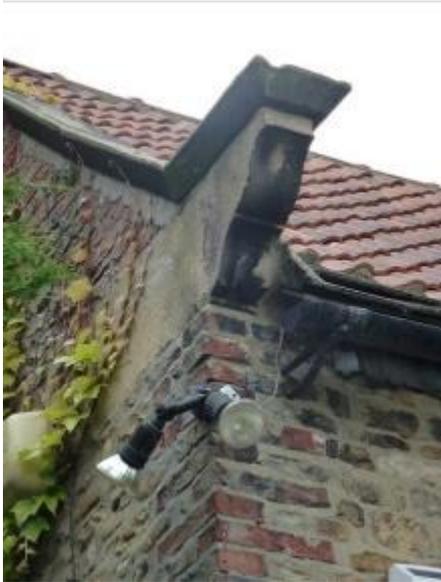
Photo 12

course with shaped kneelers (photo 12), ashlar copings and brick end stacks.

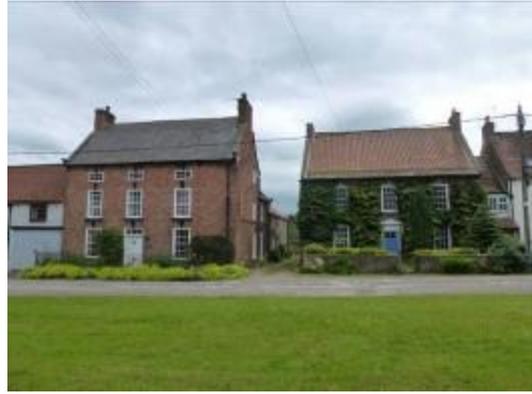
Photo 13

Ash House and Clara Meyer (photo 13) are next door to each other and both are simple robust forms with 3 bays built of brick. Ash House is 3 stories with the third storey being an attic level the building windows are vertical sliding sashes with glazing bars on the two lower levels (photo 14) and half sized blind openings at the attic level, painted as six panes. The gable has an excellent example of the Yorkshire sash window (photo 15). The roof is Welsh slate which is a 19th Century alteration and uncommon in the village, but it has retained shaped kneelers and ashar copings. Clara Meyer is a two storey brick building with

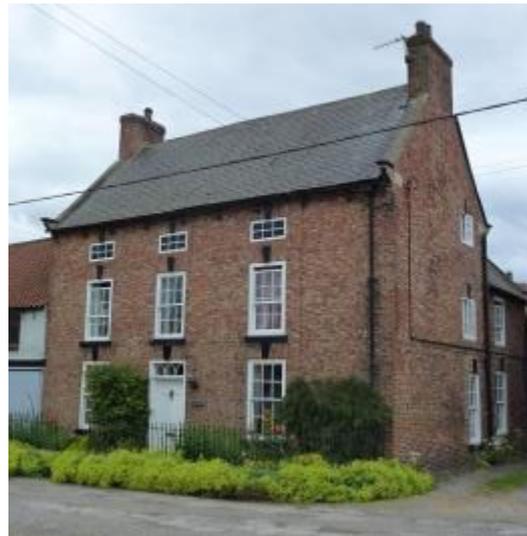
Photo 19

These building details from the older properties within Scorton are reflected in the late 18th and 19th Century properties that developed in a continuous form fronting on to the Green, though they tend to be on a slightly smaller scale. The properties are generally two storey, though the odd three storey property exists such as Ash House (photo 19) on

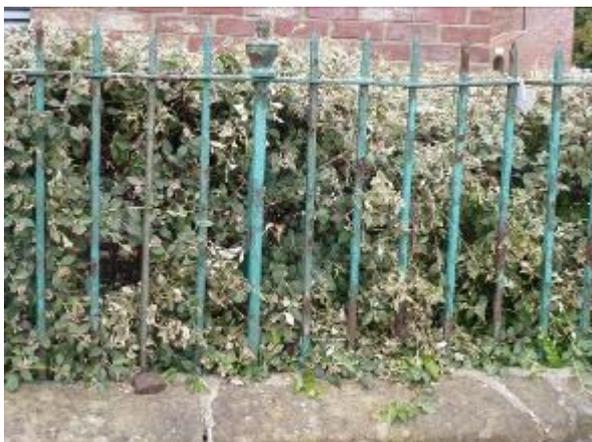
Photo 21

for properties to have porches, most doors are either four or six panels opening onto small garden frontages often enclosed behind a stone or brick wall/plinth and railings (photo 21). Those that had no private space opened directly onto the green most likely with a small earth or cobbled forecourt area (photo 22). Examples of the cobbles remain in front of Mill House and Mulberry House .

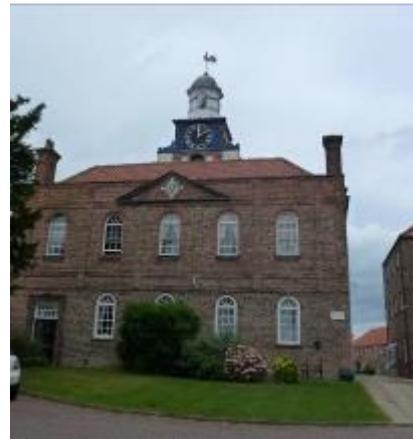
Photo 23

The former Grammar School (photo 23) is an imposing purpose built brick building from 1760 constructed by Rev John Noble at his own expense. The mass is a double depth plan of two storeys with the five bays (windows) at first floor divided by buttresses paired at corners and rising from a double band. At the top the two bands delineate the round M-section hipped pantile roof. It has a panel door with a 12 pane overhead and rubbed brick eared architrave with bases on a tall dado. The windows have round-headed sash windows with glazing bars and brick headers with projecting keystones on the ground floor and surrounds of stretchers over shaped brick aprons on the first floor. There is a sandstone pediment with the coat of arms placed centrally. The central clock tower has double quoin strips of chamfered rustification supported by scrolls. The wooden octagonal cupola with lead-covered roof and a weather vane is visible from miles around and an eye catching feature

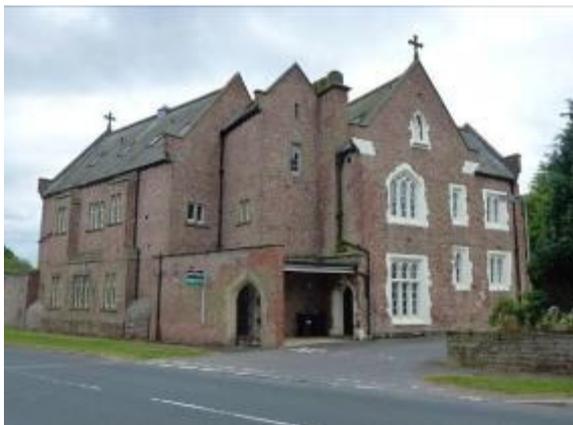
Photo 24

The Abbey Care village is made up of a number of very large scale buildings. The oldest and most modest in size being the former St John of God Hospital (photo 24) and which flanks the south side of Hospital Road. This building is thought to date to the early 19th Century and was The Poor Clares' convent building. The premises were vacated in 1857 when it was bought by a Cistercian Priest and became a hospital for the old and infirm. The building is generally 'L' shaped in plan in the Jacobethan style and is unique in the village. It is of two storeys with attics and is built of brick with ashlar dressings and a Welsh slate roof with shaped kneelers and raised verges. It features Tudor-arched doorways and chamfered mullioned windows with pointed arched lights. A pointed arched niche has a statue of St Clare. The next

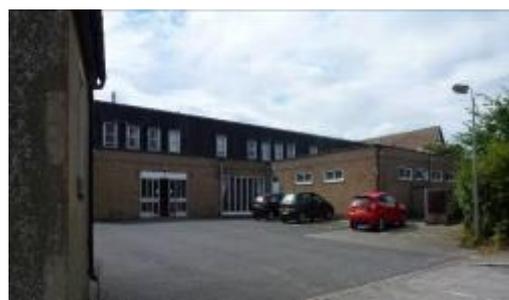
Photo 25

to the west is a 20th Century two storey flat/ mansard roofed building (photo 25) that is of no particular interest to the character of the Conservation Area. Its massing is at odds with the general grain of the village but it is fortunate that in many views it is set behind the War Memorial Institute and the high boundary wall (photo 26). The central block (photo 27), a three storey brick and Welsh slate structure with good detailing to windows including drip moulds and voussoirs at ground floor and brick arches at second floor is set well into the site and

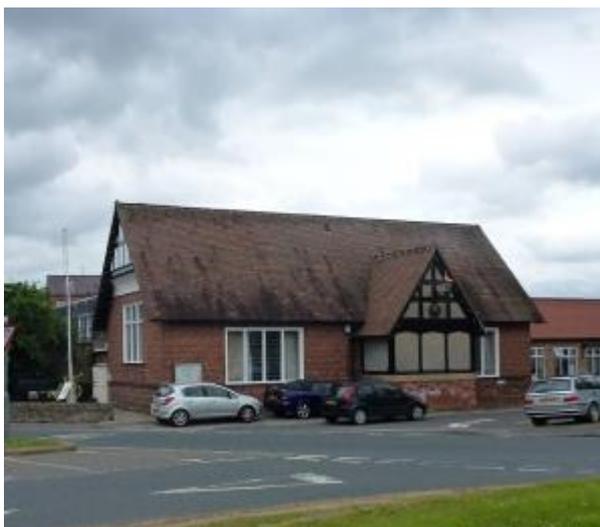
Photo 29

The Institute (photo 29) occupies a prominent position centrally on the east side of the Green. This late 19th Century building in an 'Arts and Craft' style is of its day and introduces a form of architecture not found elsewhere in the village, that of a timber structure with render and

brickwork. It similarly used a flat tile for the roof which is again not the local vernacular of the village. This differing architectural design sets the building apart from its neighbours and it dominates the eastern side of the Green but the use of clay tiles, render and brick also assimilates it into the wider village.

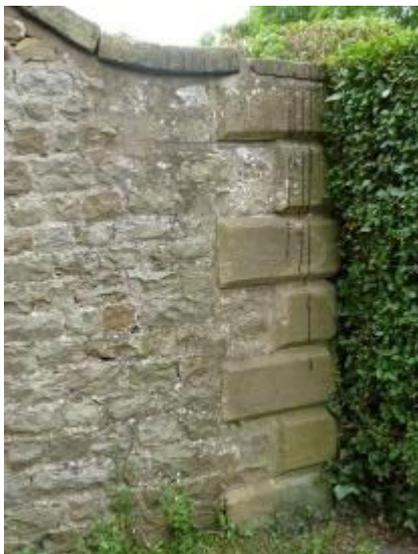
Photo 30

Most of the stonework that is evident is of coursed rubble and this can be seen on Virginia House with quoins (photo 30). In many cases the stones have unique rounded corners to the individual blocks giving a cobble style, but there

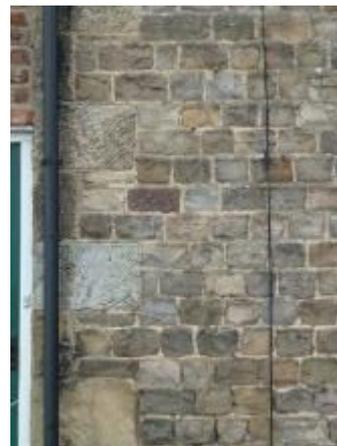
Photo 31

is a huge variety (photos 31 and 32). The sizes and shape are generally too regular to be true cobbles, which tend to be more random in size and shape. Most of the faces have a

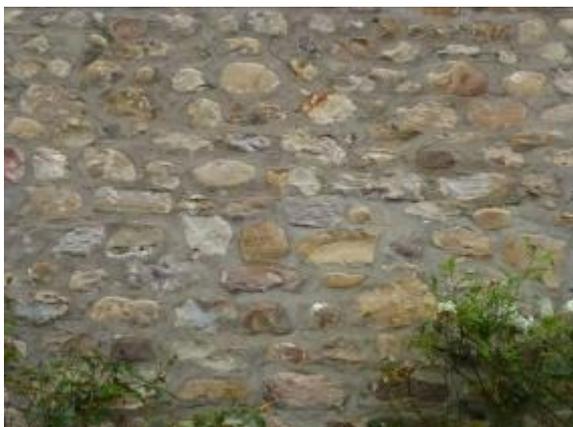
Photo 33

and the use of numerous small infill blocks within a course also give clues that stonework was likely to have been originally covered (photo 33). The passion for stonework in the recent past has seen the removal or render and this has impacted on the historic visual character of the village.

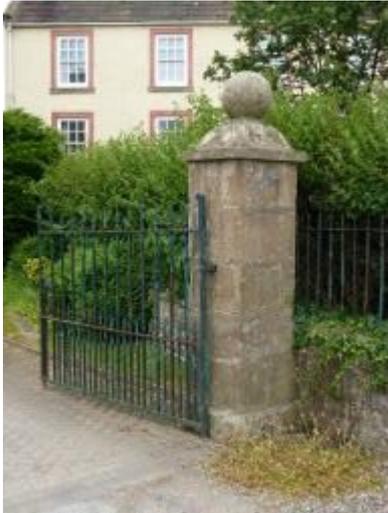
Photo 34

Ashlar and high quality dressed stone seems to have been used in Scorton for details such as the gate piers to the Grammar School which have rusticated bands, a cornice, ogee caps and ball finials (photo 34). Similarly at Swale View ashlar stone has been used for the gate piers with chamfered rustication, ogee bases and ball finials whilst on Rose Cottage stone is used to form an ornate surround (photo 35).

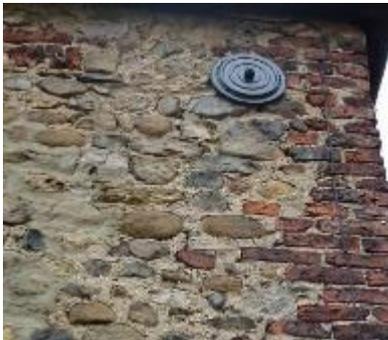
Photo 36

True cobbles are generally restricted to outbuildings and walling that was not going to be visible i.e. the rear or gables of properties, or hidden under a render of limewash (photos 36 and 37). This is clearly shown on 1 and 2 St Johns Terrace where the front is good quality coursed stone with quoins whilst the gable/side is cobble (photo 38).

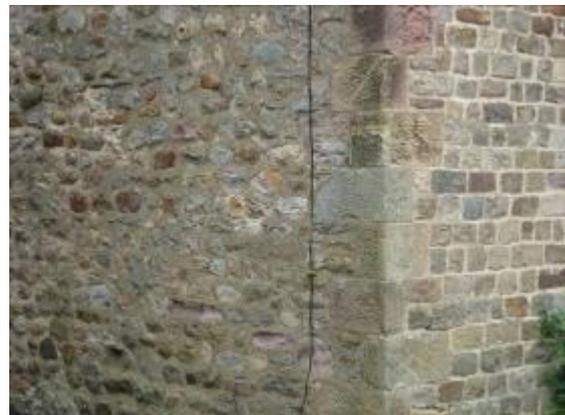
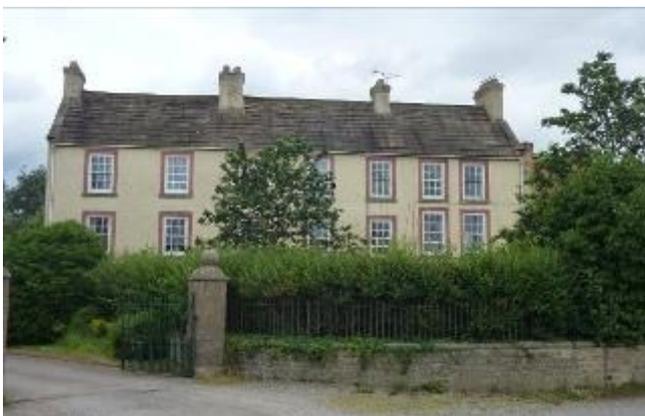
Photo 39

cases and particularly during the 20th Century render achieved acceptance as a finish in its own right. There are two main forms of rendered finish, the traditional roughcast finish as seen on Mill House and School House (photo 39) and a smooth hard float finish of which The Chapel in the Abbey Care Village is an example (photo 40). Sometimes the latter has a textured pebbledash applied on top (photo 41).

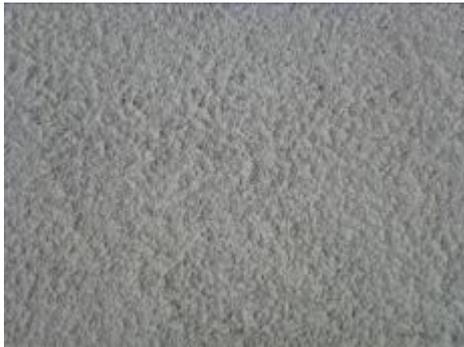
Photo 42

The traditional roughcast render was formed of a lime-based mortar with a large gauge aggregate included for bulk. It created a distinctive rough texture and remains very successful at sheltering poor quality stonework from weathering (photo 42). Where a building was designed to have a rendered or plastered finish and this has been removed, the revealed stonework may be of a poorer quality (photo 43). In other cases render has been applied to harmonise a group of buildings or to disguise alterations.

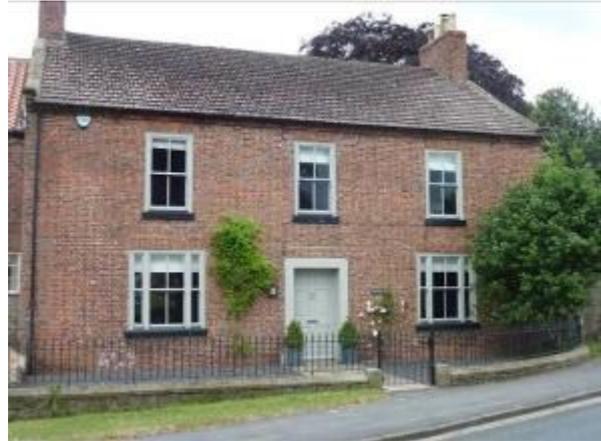
Photo 46

Around 11% of the buildings in the village are of brick construction and it also appears in details and minor areas of repair such as dressings to openings and chimney flues and breasts. The bricks used on the older properties are all hand-made and of local origin demonstrating irregularities and fractures (photo 44). These can be seen on St John of God Hospital, Ash House and the Old Rectory (photo 45). The fire-skin of these bricks is not well developed as they were fired for longer periods at lower temperatures. The brick details are shown well on Manor House (photo 46) and elsewhere (photo 47).

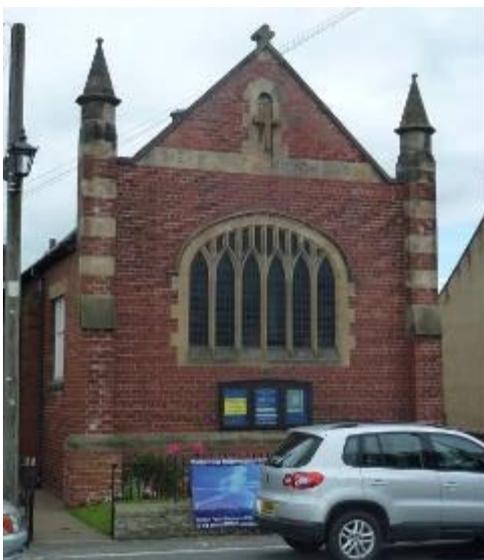
Photo 48

Bricks from this and later centuries are harder with crisp edges and came in a wider variety of more uniform colours as can be seen on the Methodist Church (photo 48). Broadmead House and the village shop and post office (photo 49) have a frontage constructed of white bricks which are certainly at odds with the character of the rest of the Conservation Area and is an example of the influence of improved transport links and a move towards large scale manufacturing processes. The use of brick has been carried into the 20th Century with example such as 3 & 4 St Johns Terrace (photo 50) and Ancient House (photo 51), but the uniformity of the brick and the lack of detailing makes the properties stand out slightly from the norm for the rest of the Conservation Area.

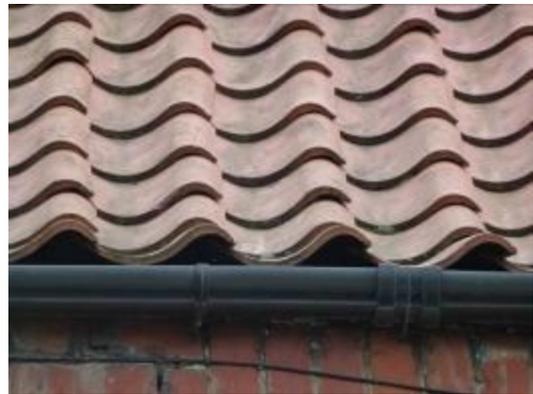
Photo 52

Pantiles are the most widely used roof coverings in the village and appear to have been the dominant roofing material for many years (photo 52). They vary greatly in age and character and their different ages and sources combine to produce a richly textured roofscape to the village when viewed from the Village Green. Several village properties have eaves courses of stone slates, a traditional and interesting vernacular feature which can vary in width from a simple single course to three or four courses of stone.

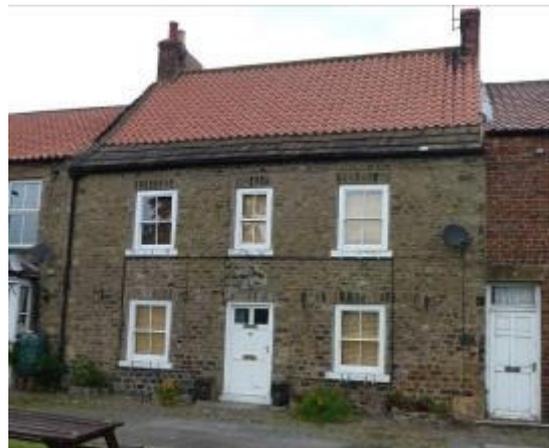
Photo 55

Some of the original roofs of the village have been replaced with interlocking pantiles (photo 55) such as at 2, 5 & 6 St Johns Terrace and though these do not quite have the character of the original, they assimilate reasonably well into the over all street scene.

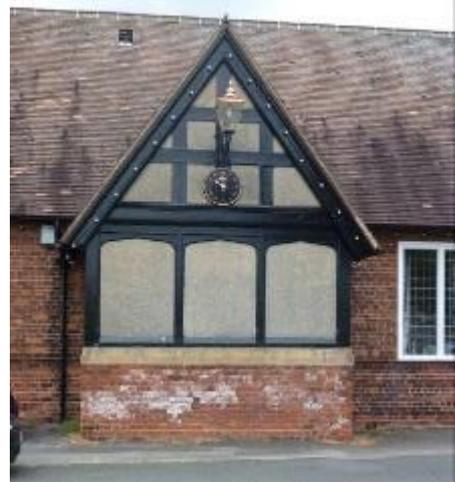
Photo 56

Clay flat tiles exist on a few properties in the village such as at The Homelands and The War Memorial Institute (photo 56) and though these are noticeably different from the profiled tiles, their material and colour help to assimilate this type of tile into the roofscape.

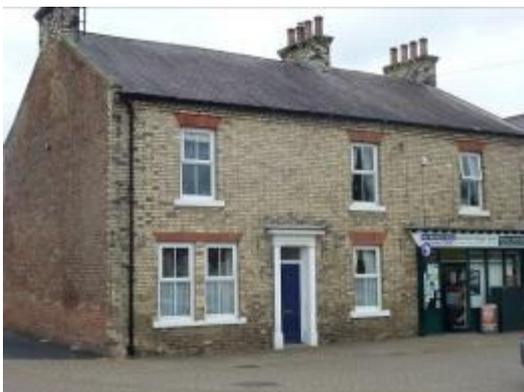
Photo 58

these are best seen at Broadmead House and the village shop and post office (photo 58).

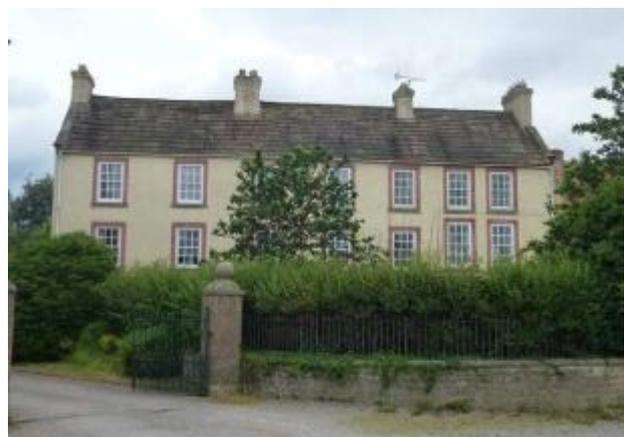
Photo 59

Locally sourced Dales stone slates are rare and only the only entire roof covered in these slates is the former School House now known as Leonard House (photo 59). They are used more frequently as an eaves course on Pantile roofs such as at Virginia House, Clara Meyer (photo 60) and the Manor House. This is an important local tradition.

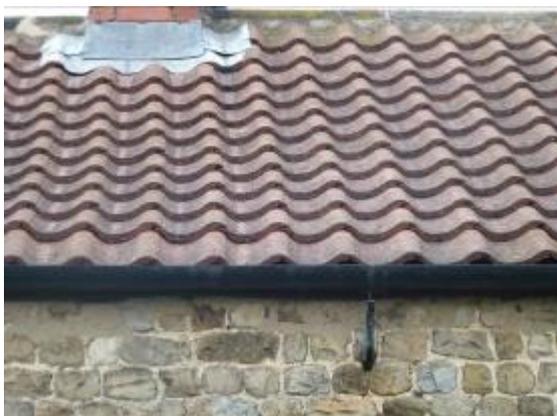
Photo 61

These include concrete tiles – flat, profile (photo 61) and interlocking (photo 62) - that have been used extensively on properties through the 20th century to replace older roof coverings. Although not ideal for the building due to the added weight and characteristics of the material itself these tiles have usually mellowed with weathering to blend into the street scene such as those on the terrace to the north of Hospital Road (photo 63). Ideally these will be replaced with more traditional alternatives as they become life expired.

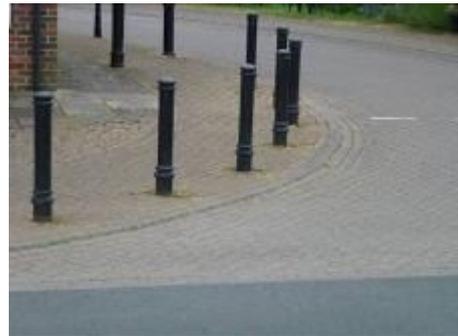
Photo 67

In several locations modern block pavements have been introduced, namely at the access to Westfields (photo 67) and Grammar School Court.

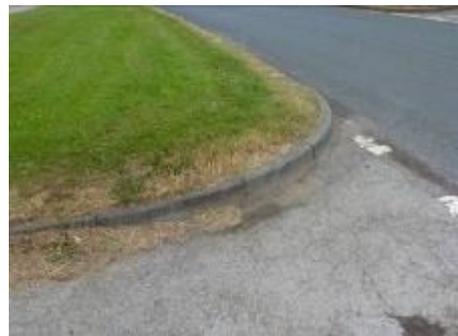
Photo 68

Most street and grass edges are formed with standard concrete kerbs (photo 68).

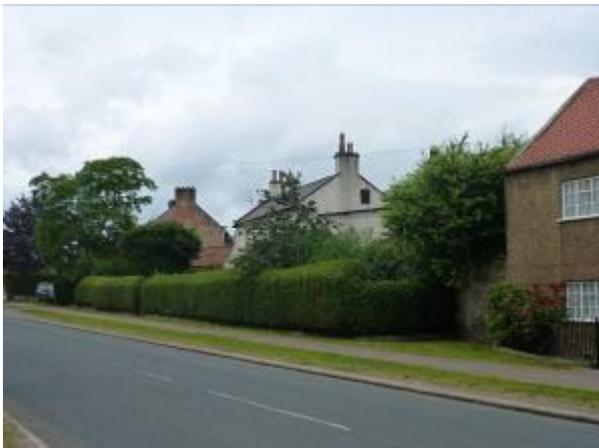
Photo 72

supplement the existing such as at Scorton Lodge (photo 72) where the stone plinth and railings have been somewhat over powered.

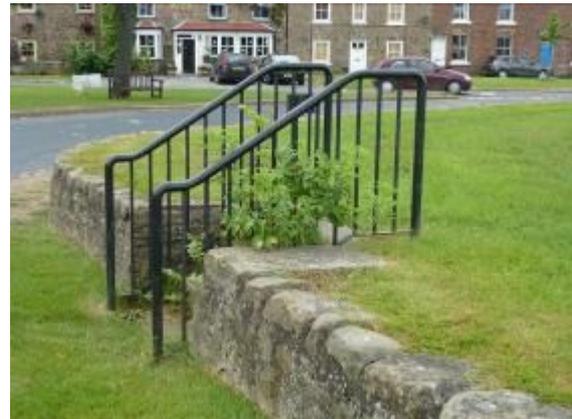
Photo 73

Uniquely the main part of the village green is at a raised level that is bounded by a stone wall and then accessed by a series of stone steps. One of these have had a very modern tubular steel handrail introduced (Photo 73), which looks a little incongruous.

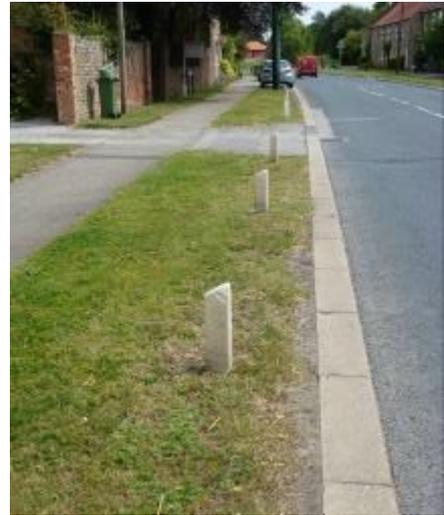
Photo 78

telegraph poles (photo 77). There are, however, some particularly unfortunate items such as the monster telephone poles on Hospital Road where the lantern style street light fitting looks completely out of context and the small white plastic bollards along Hospital Road (photo 78).

Highways signs condensed and signs on walls where possible	Internally illuminated plastic bollards around the village green	Replace with more appropriate design
Free from street clutter	Random 'A' boards on the street/ green	Traditional signage at premises

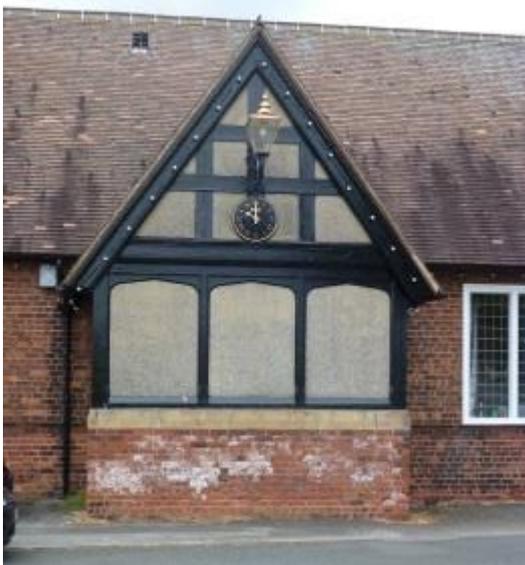
Photo 81

Of particular note in the village is the use of 'clocks' as a feature and a focal point. The clock tower on the Old Grammar School is visible from both inside and outside the Conservation Area (photo 79). The clock on the Scorton Memorial Institute is a focal point from the Green (photo 80) and the gable presentation of the clock on the Abbey Care Village is a focal point of the courtyard area off Hospital Road (photo 81).

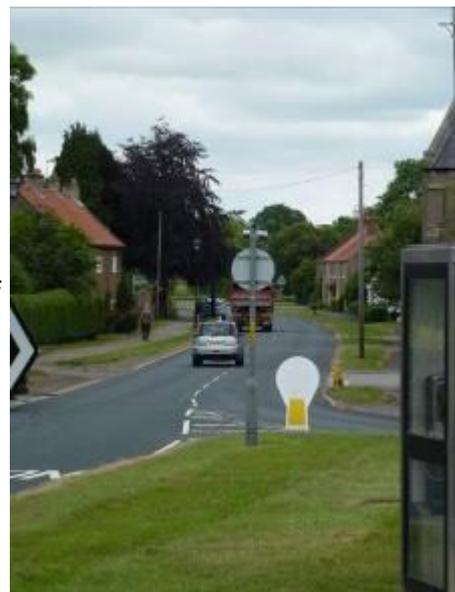
Photo 88

This area forms the most prominent and a highly attractive part of the village. The buildings are arranged around a large and dominant village green (photo 88). The triangular central and largest area of the

Green is bordered by roads and unusual in that it is raised above the level of the surrounding village by stone retaining walls. The plan form of the larger space including the subsidiary greens creates a roughly rectangular shape between the buildings, being well defined on the western (photo 89), northern (photo 90) and southern (photo 91) sides by tight building groups and terraces. The scale of the surrounding houses and cottages is

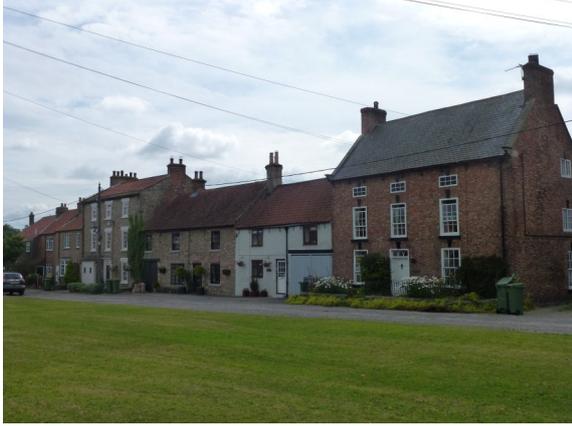
Photo 96

overall townscape quality (photo 96).

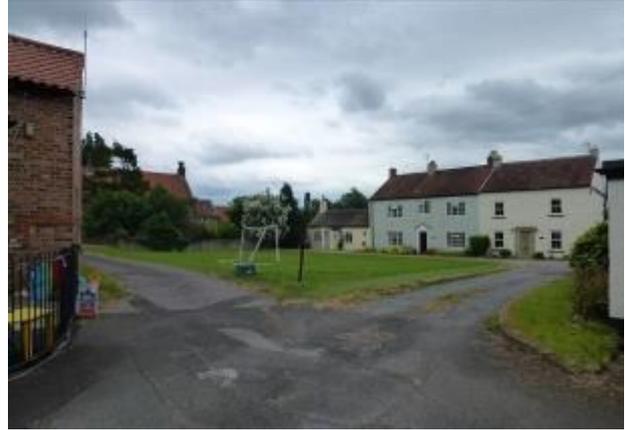
Photo 97

This area (photo 97) was formed when the group of properties consisting of the former Post Office, Smithy and Forge were built on the south east side of the Green

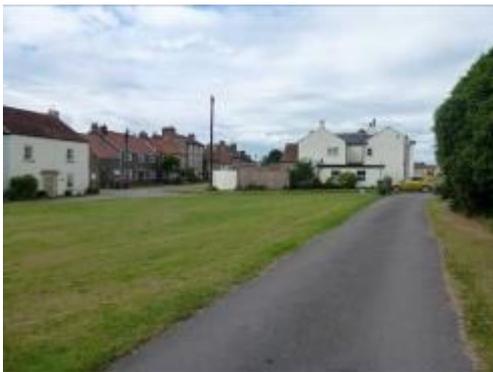
Photo 98

(photo 98) effectively separating it off from the wider Green area. It is now tucked away from the main Green hidden by the group of buildings and is rectangular in

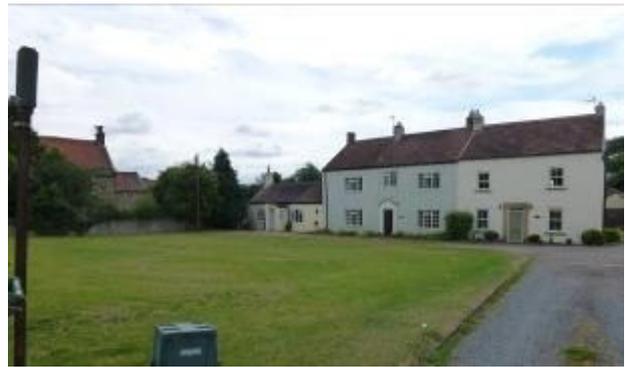
Photo 99

shape, bound on four sides. To the east, south (photo 99) and west (photo 100) are houses and to the north the high boundary wall of the Abbey Care Village (photo 101). The oldest house in this area is Manor House, a very imposing 18th Century property on the east side which stands apart within its own mature gardens (photo 102) separated from the Green by a stone wall. To the south is a terrace of three traditional properties which front straight on o the Green, the easternmost of which is single story - an unusual occurrence in the Conservation Area. The former Post Office forms the boundary to the west.

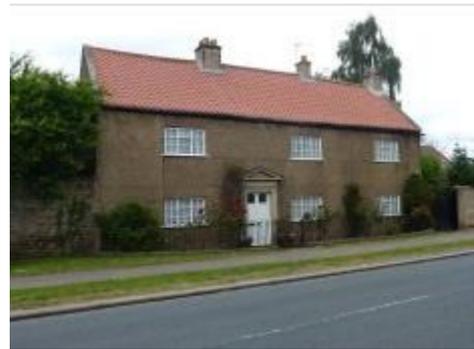
The properties along Hospital Road are more dispersed than those found around the Green. The greater part is made up of detached properties some fronting close to the road (such as Rose Cottage (photo 103)), and others set slightly back

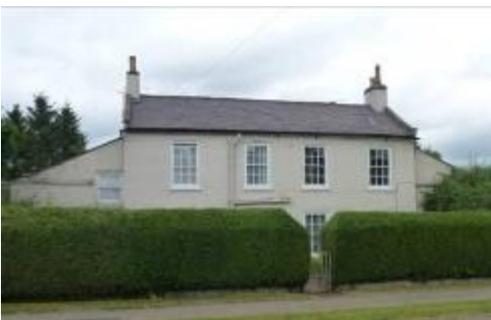
Photo 104

from the road like Scorton Lodge (photo 104), with some set yet further back from the road like Rose Villa. The distance that Rose Villa is set back means that the building itself has no contribution to make to the character of the Conservation Area. This is a linear form of development where the eye is drawn forward and lacks the feeling of enclosure that the Greens have with the sense of enclosure only returning towards the eastern end

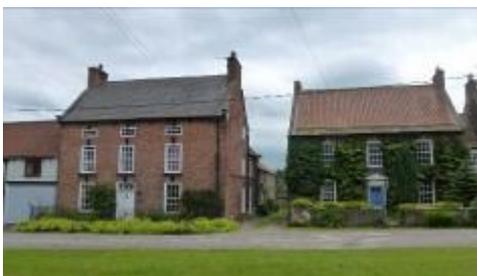
Off the main Green area there are a number of small alleys such as Flywheel Street that provide access to other properties (photo 110). This particular street has retained a substantial amount of its cobbled surface. These areas are generally accessed through an innocuous gap in the buildings, such as the access to Honeysuckle Cottage (photo 111).

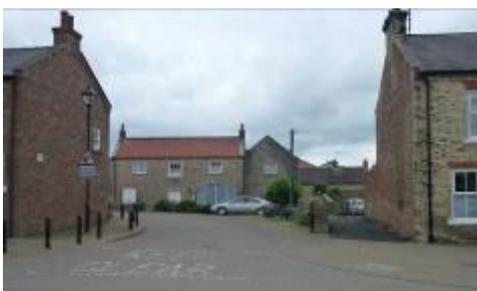
Photo 113

The properties tend to be small two storey buildings of a traditional form and materials (photo 112). The exception to this is the access to Westfields and the modern development lying outside the Conservation Area. Here the access is wide and designed to modern highway standards and looks a little incongruous. Its saving grace is the view provided to a very fine barn which is now flats but has retained a wealth of character (photo 113).

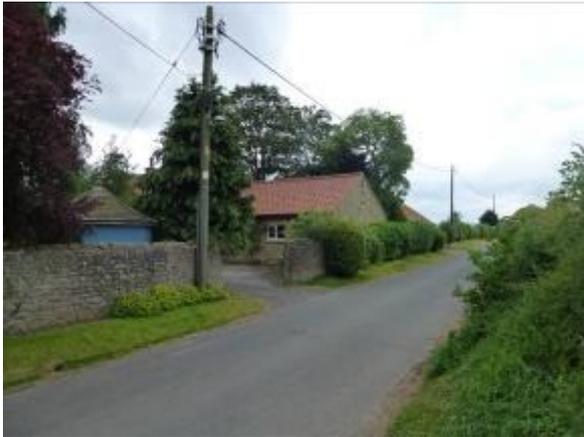
Photo 114

This area is behind the frontages to the north west of the Village Green. Based originally around Home Farm and its numerous farm buildings, the area has seen a change to its character as detached new properties have been developed not always in a form that is in keeping with the character of the Conservation Area. The two new bungalows, The Sycamores and Greenholme are particularly at odds with the general character in terms of their form and design (photos 114 and 115). Only

their use of materials and location away from the village centre and the boundary treatment helps to play down their visual intrusion.

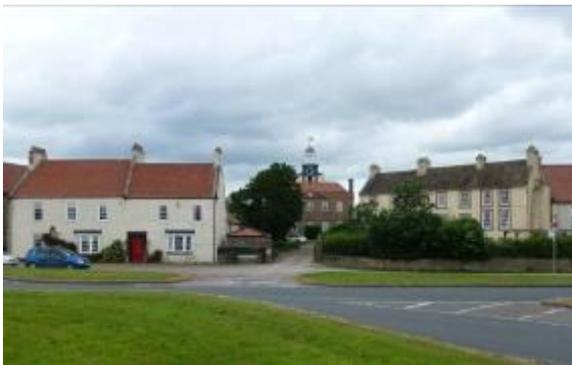
Photo 121

Focal points within the Conservation Area have been mentioned in previous sections and these consist of the Old Grammar School (photo 121); the Abbey Care Village clock tower (photo 122); the gable of the Methodist Church (photo 123); the Scorton Memorial Institute (photo 124); and the former St John of God Hospital .

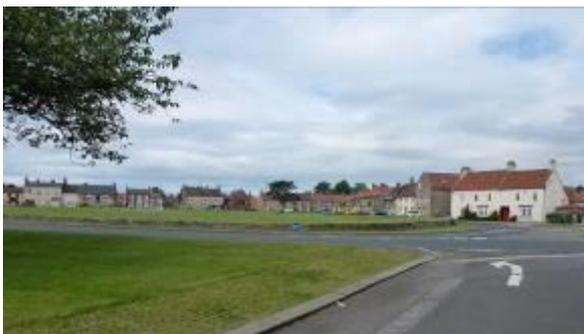
Photo 123

have been built on the original open space and their orientation is at odds with the general grain of the layout of the village and their effect on the character of the village is highlighted by their prominent location. With only a few exceptions, the buildings in this area run roughly parallel to roads. The exceptions being Kinnegad (photo 94) on the north side and the Methodist Church (photo 95) on the west side,
