THORNTON STEWARD

CONSERVATION AREA APPRAISAL AND MANAGEMENT PLAN

Adopted as Supplementary
guidance on 24th February
2009

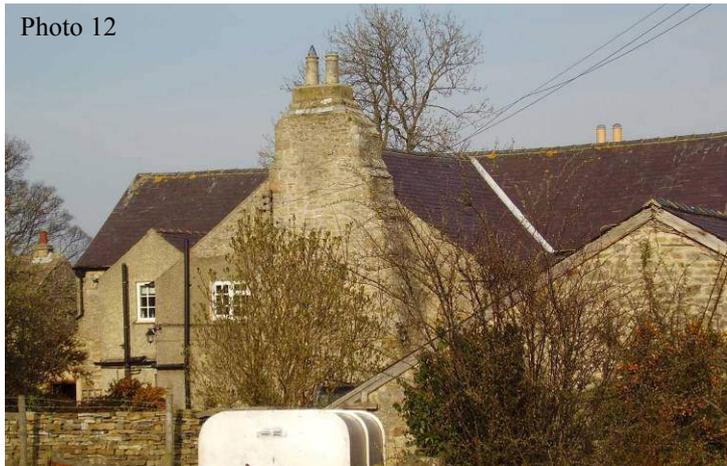
Photo 12

The oldest surviving property in the village is the listed Old Hall (photo 11) dating from the 16th century but possibly on a much earlier site dating from the 12th century. Although much altered and extended over the centuries the huge projecting chimney stack with weathered corbelling (photo 12) and the mullioned windows set in moulded stone surrounds (photo 13) provide a clear indication of the antiquity of

although many later additions and alterations have been made. The earliest lower courses of the building comprise large river boulders from which the random rubble walling rises (photo 41). A massive chimney to the west elevation is of random rubble with dressed stone detailing (photo 12). At The Manse the prevailing rubble stone is part rendered to some of the rear elevation (photo 42) and rusticated quoins

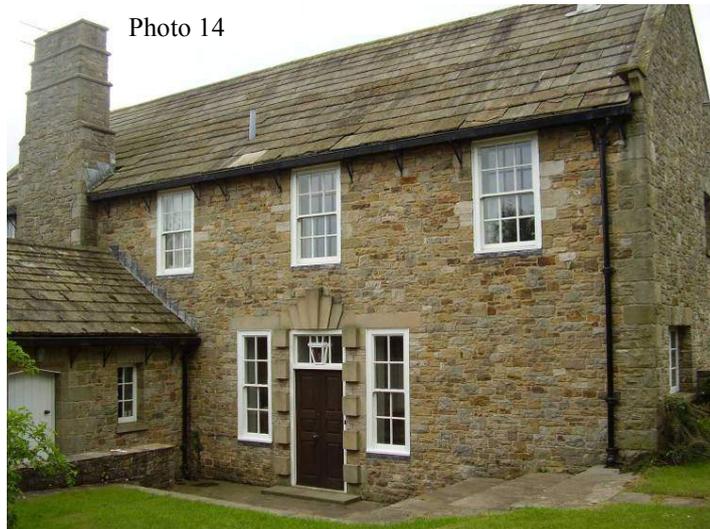
Photo 14

the building. Manor Farmhouse at the extreme west end of the village provides the next phase of surviving development in the village (photo 14). Dating mostly from the 17th century it retains many of the older features of post medieval architecture such as the mullioned and transomed windows, the shaped kneelers and raised copings to the

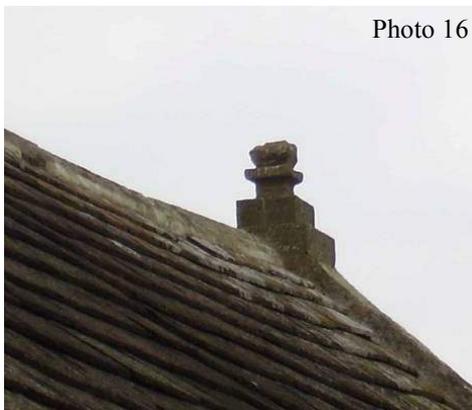
Photo 16

eaves (photo 15) and the carved finials to the peak of the roof (photo 16). It is possible the house was originally built with an E shaped plan form, as it was a popular style in Elizabethan England however the passing years took their toll on the property and one wing of the building was lost. The careful restoration in the later part of the 20th century recreated the original layout with a newly built wing to the right hand side.

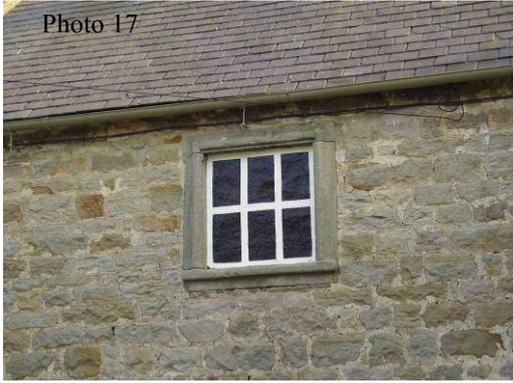
Photo 17

Dating from the first quarter of the 18th century The Manse is the nearest neighbour to Manor Farmhouse. Typical early Georgian features survive here too with bolection mouldings to door cases and windows and the inclusion of a carefully detailed blind window on the very public rear elevation (photo 17). Much well detailed historic timber is also reputed to survive inside the house. The oldest of the modest

frame the southeast corner of the building. Moulded masonry detail includes detailed stone surrounds to doors and windows, ashlar raised water table copings to the gables with shaped kneelers (photo 42) and bolection surrounds to the doorframe and rear blind window on the north elevation (photo 17). The chimneys here are of brick and whilst on the main house they may date from the properties early 18th century date it is thought that the rear chimney has been rebuilt in the 20th century. The Manor House is of two principle phases the first in the later 17th

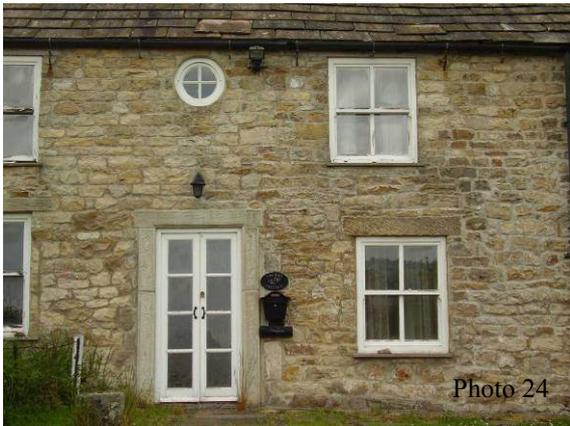
Photo 24

these buildings is broadly similar however each has its own peculiarities and individual identity as illustrated at Cherry Cottage where a circular first floor window marks the house as different from its neighbours (photo 24).

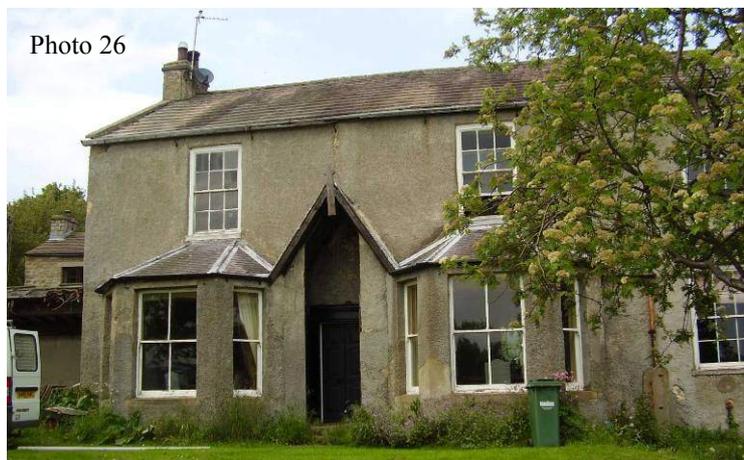
Photo 26

eccentric Captain Horn of the Loyal Dales Volunteers, possibly as a barracks for the local militia in which he held a commission, it is thought to date from the early part of the 19th century and carries several of the popular architectural devices of the late Georgian period. This type of militia mustering point or barracks proliferated during the Napoleonic wars when there was considered to be a real threat of invasion by France. Of note are the three storey canted bay window, the flanking Venetian windows both popular at the time and the castellated parapet to provide a hint of military pretence. The Villa sitting away from the Green in a secluded corner of the village is a substantial late Georgian property dating from the 1830's (photo 26). It differs from the more numerous cottages in the village in its scale and its rendered finish, a

Examples of render in the village include The Villa (photo 26), dating from the 1830s when lined out stucco and render were popular finishes for buildings reflecting the stylish grand Regency buildings of the time. The nearby Old Vicarage (photo 51) is similarly rendered in appearance however here the finish is a more modern. Historic render can be seen in places on the older sections of the Manse (photo 42) however it is extremely weathered and degraded. In this form render has a distinct attractive aged character that is impossible to recreate in repair, but work will be required in the future to maintain the

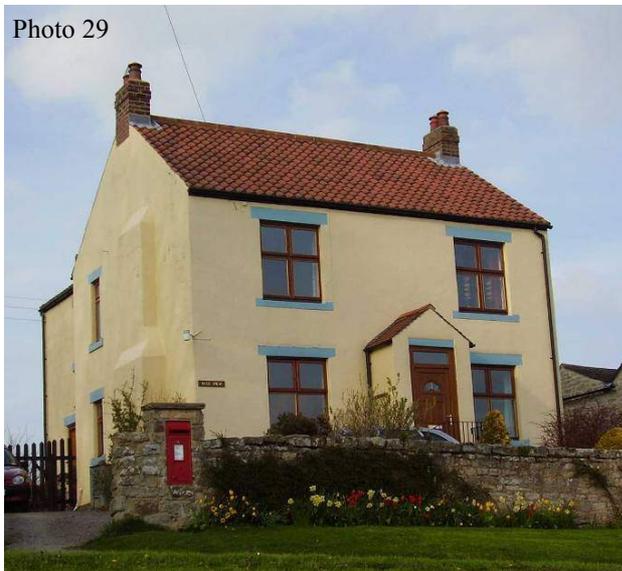
Photo 29

weather tight integrity of the wall. This is an instance where the render has fulfilled its purpose of providing a shelter coat to the underlying stonework thus lengthening its lifespan. The most prominent example of render is at Dale View (photo 29). This 19th century house has been completely rendered and painted. The colour is not unduly harsh in the village however the smooth finish of the walls contrasts markedly with the rougher

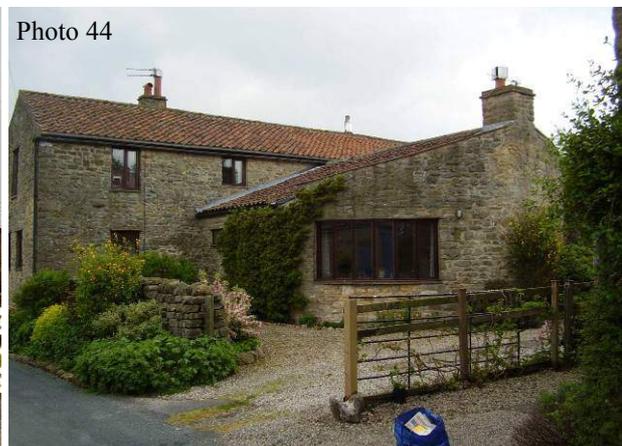
Photo 44

Random rubble, typified in the construction of Plane Tree Cottage is widely used throughout the conservation area for both more modest houses and barns. At Plane Tree Cottage the quoins are of random widths and dressed only to the two exposed faces whilst the coursing of the stonework is extremely random (photo 43). At the Round House (photo 44) a similar form of walling is used however the sills and lintels for doors and windows are slimmer and formed of slabs of sandstone laid on the bedding plane rather than being the more prominent deep sawn heads found on Plane Tree Cottage. The barn to the Round House has well-proportioned regular

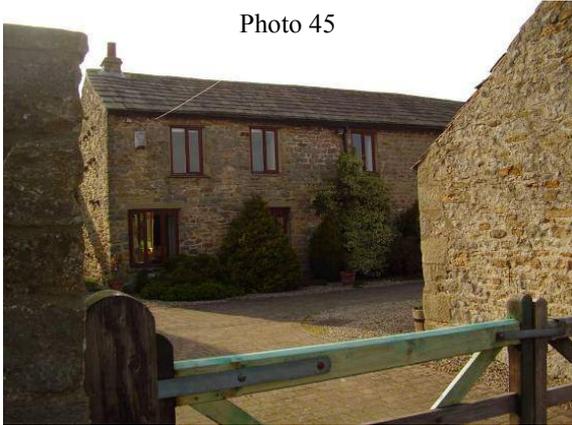
Photo 45

quoins and this treatment is continued throughout this former farm group to the Old Stables (photo 45), now converted to residential use. School Cottage (photo 46) has smaller quoins and a segmental

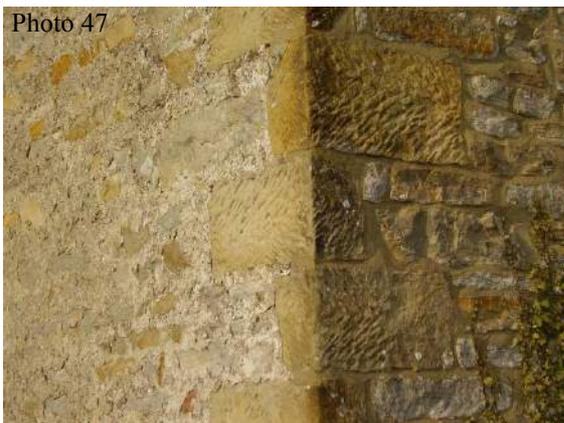
Photo 47

Examples of this are the sawn stone dressings at Stone Fold (photo 31) and at The Old Post Office, where the quoins are tooled with a herringbone finish (photo 47). Sawn ashlar stone has been used for inscription tablets in both the school building (photo 28) and at the Institute building (photo 30).

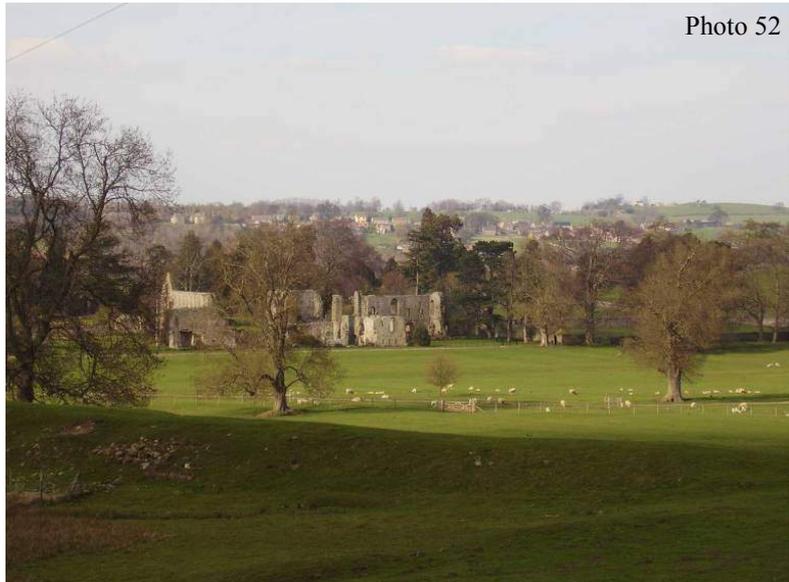
Photo 52

appearance of the neighbouring stonework. The combination of the finish to the walls and the position of the building make this property one of the most striking in the village, even being visible in views across the valley (photo 52). A less obtrusive use of render on an historic building has been at the cottage where a modern first floor extension over an old random rubble wall has been rendered and painted a complimentary colour to the stone (photo 53). Although this form of honest approach to alterations can

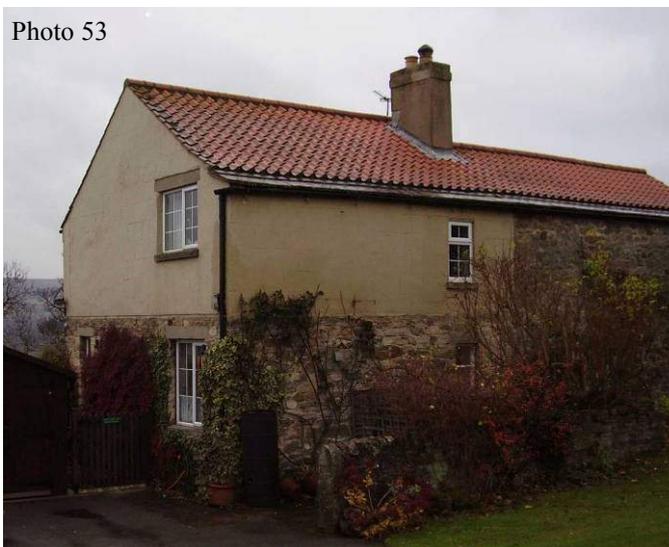
Photo 53

work well it is important to ensure that the final result blend two phases of build together acceptably and does not leave a jarring contrast. The final use of render of note in the village is to the 1950's properties at Field Side (photo 10). Here the pebbledash render has weathered to a grey colour over the intervening 50 years and gives the properties a stark appearance belying their quality of design.

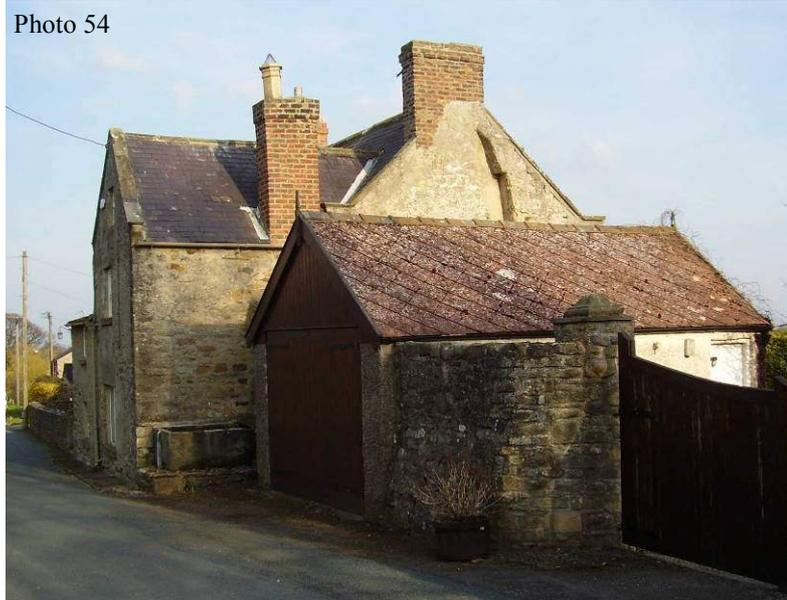
There is almost no brick used within the village with the exception of the chimneys to The Manse (photo 54), some small, patched repairs to South View Cottage and one of the older garages to the rear of Pear Tree Cottage (photo 55). This reflects the abundance of good quality building stone in the area and possibly the lack of readily accessible clay for brick making. Prior to the 20th century buildings would reflect the locally available

materials and traditions, i.e. have a vernacular character, transport was difficult and expensive and thus bricks would not have found favour with those constructing properties in the village. The use of bricks at The Manse shows the status of the building and the occupier and the prominent chimneys clearly show off this expensive imported material to the residents of the village. At the Manse two different phases of brick are evident, the older narrower 2" bricks typical of the 18th

century and some well matched 20th century bricks employed to repair the rear chimneys. The older bricks will be hand-made and of relatively local origin demonstrating irregularities, fractures and a wide range of colours. The fire-skin of these bricks is not well developed as they were fired for longer periods at lower temperatures. The garages to the east of the village are a very different

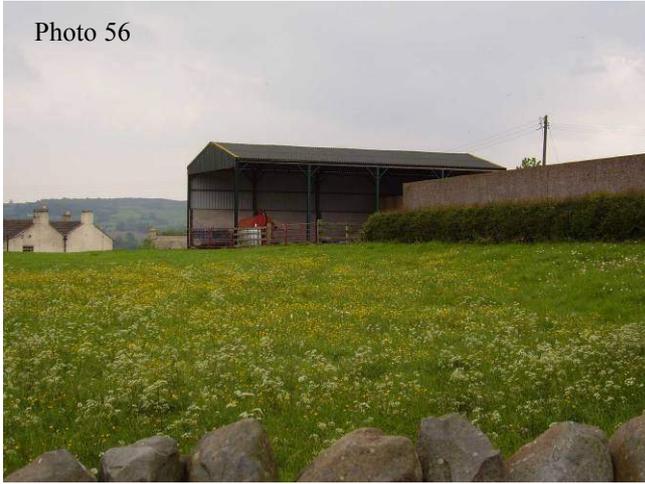
Photo 56

Whilst the majority of buildings are constructed of stone, sometimes with a rendered finish there is a limited range of other materials used occasionally through the village that should be mentioned. Principle of these is the use of metal sheeting mostly for the larger agricultural barns. Although not normally a part of most villages the recent barn to the south of Plane Tree Cottage is prominent in

views of the village from the east (photo 56). Similarly at the west of the village the entry to the conservation area is flanked to the north by the corrugated sheet barns of Manor House Farm (photo 57). This type of large agricultural building is also important within the fields to the north of the village (photo 58). In most cases the buildings also incorporate blockwork into their structure. These

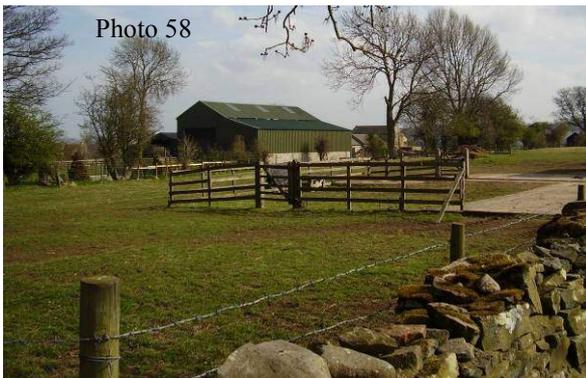
Photo 58

buildings are essential to the functioning of the village and, although not complimentary to the character of the conservation area, they have a distinct identity that is appropriate within the rural area. Within the heart of the conservation area the building to the west of Dale Side is the most prominent structure that

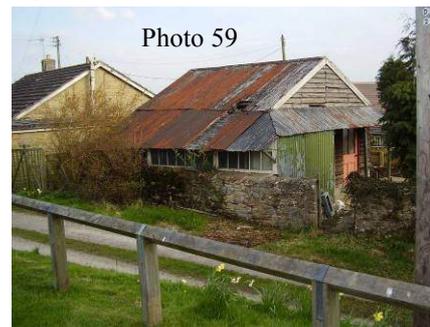
Photo 59

uses sheet materials (photo 59). At Woodcote the 1970's style bungalow uses timber cladding to its front gable (photo 34) and several of the garages, small barns and other ancillary buildings throughout the village employ either timber or corrugated sheeting in their construction (photos 60 and 61). These are

bearing on the character of parts of the conservation area. Particular examples include the agricultural barns to the rear of Urebank (photo 68) and those to the north of Manor House Farm. Most prominent in the conservation area are the outbuildings to South View Cottage (photo 60) and the single storey timber framed building to the west of Dale Side (photo 59).

The final properties to the south side of the Green are those at Roker, Dale Side and South View Cottage. Roker (photo 59) is a tin sheet clad timber building in need of some repair. It has a prominent position in the conservation area and its appearance is a little different from the traditional character of the rest of the village. Dale Side (photo 33) is a late 20th Century bungalow with an attached flat roofed garage, very different from the prevailing character of the village but again

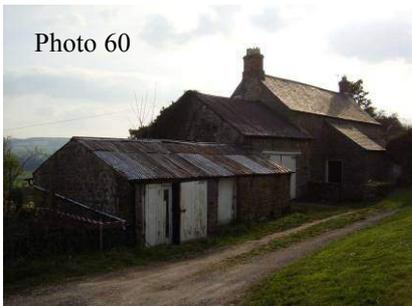
Photo 60

important to the character of the village as they add to the range of colours, textures and materials that go to make up the scenery. Whilst they may not be necessarily considered worthy of preservation in their own right the complete loss of these small modest sheds and

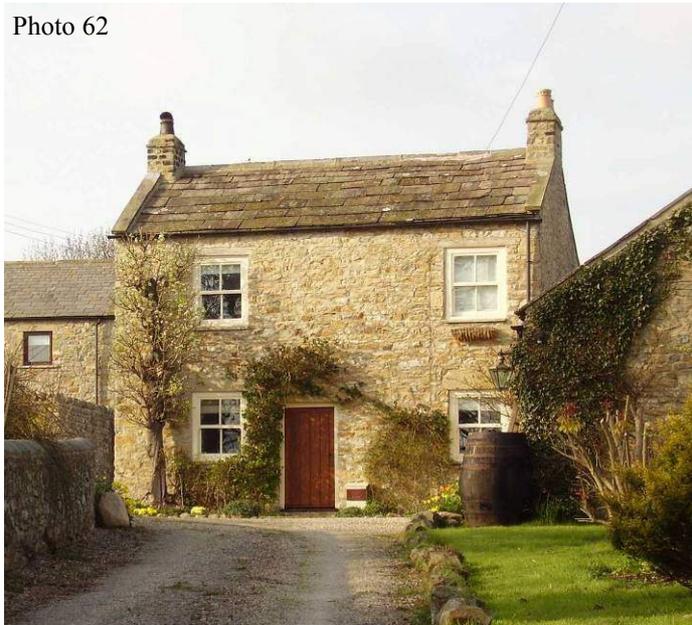
Photo 62

This is historically the traditional material for domestic roofing in the area and has been used widely on a range of buildings throughout the village. Stone slate was locally sourced and is laid in diminishing courses, narrowing from large slates at the eaves to small slates at the ridge and is often finished with a dressed stone ridge piece. Good examples of stone slate roofing in the village include Holme Farm (photo 62), where the gable verge is finished with a raised water table detail, and

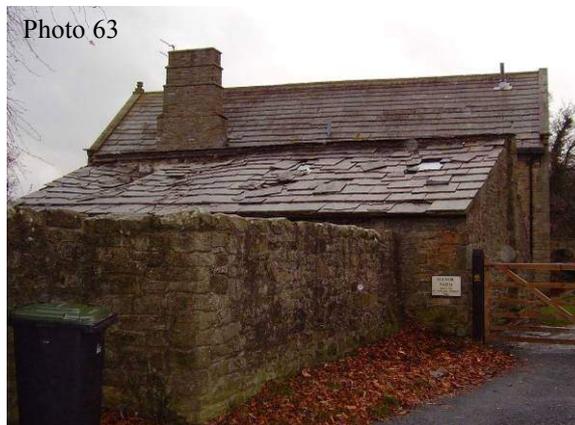
Photo 63

Cherry Cottage (photo 49) which has a flush pointed verge to the gable. The out building adjacent to Manor House Farm retains this form of roof covering albeit in need of attention on some of the outbuildings (photo 63) and at the Old Stables barn conversion the roof has been repaired for the buildings new use (photo 45). The new property at Maple Lodge appears to have continued the tradition of using stone slates (photo 40) but the slates may no longer be sourced locally.

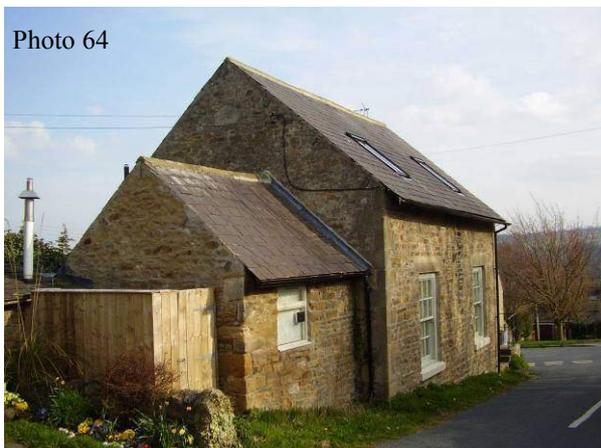
Photo 64

slates. As a material the earliest use of slate will date from the latter half of the 19th century when transport systems, particularly the railways, were sufficiently developed to allow slate to be imported to the area. The larger properties of The Manse and Old Hall Farm (photo 6) have both had their original roof coverings replaced with Welsh grey slate and other prominent buildings with this type of roof include the Old School (photo 66), South View Cottage (photo 64), the Old Post

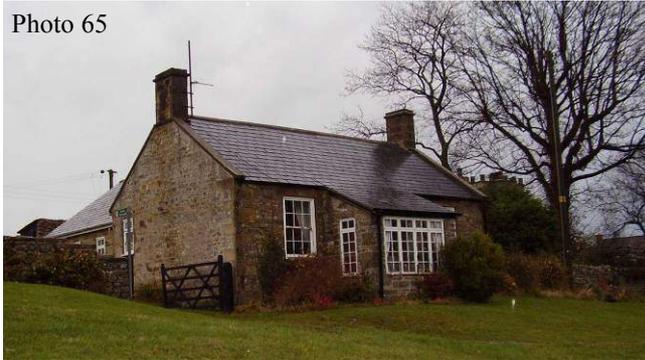
Photo 65

Office (photo 65) and Pear Tree Cottage.

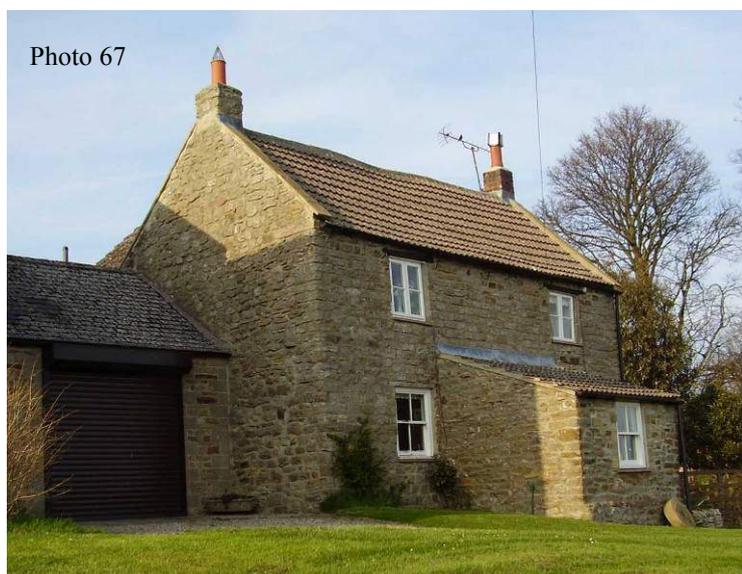
Photo 67

street scene. Ideally these will be replaced with more traditional alternatives as they become life expired. Examples of concrete tiles are found on the house at Smithy Cottage (photo 49), and at the property adjacent to Stone Fold (photo 67) where the house has concrete tiles and the garage is covered with a lightweight asbestos cement tile. There are several examples of tin sheeting coverings to barns and ancillary buildings and these do have a

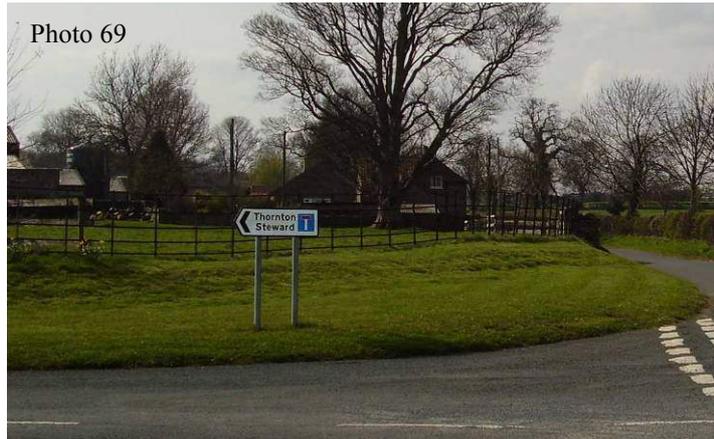
Photo 69

Around Thornton Steward there are a good variety of boundary treatments that make an important contribution to the character of the conservation area. The first sight of the village is enhanced by the use of steel estate railings around the eastern field (photo 69).

These railings are an effective boundary but still allow a clear view through to the field and village beyond. The most widespread and important form of boundary treatment in the village is the stone wall. This takes many forms from the formal, mortared wall present in front of Fort Horn (photo 70) through to the beautifully constructed and coursed dry stone walls to

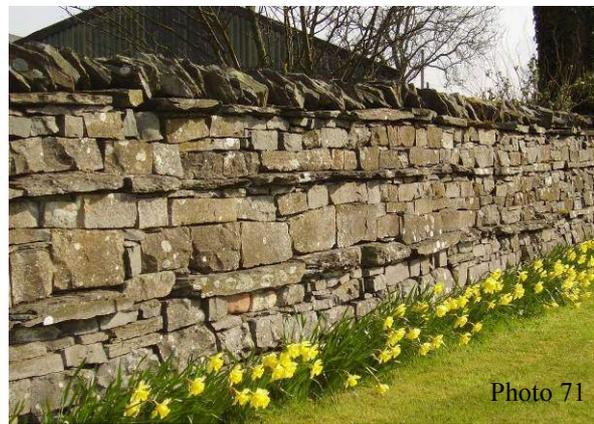
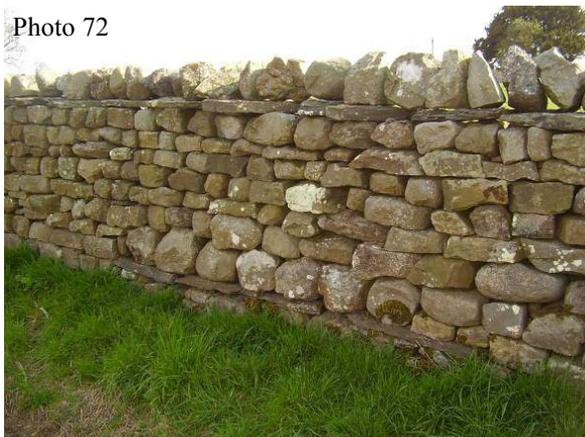
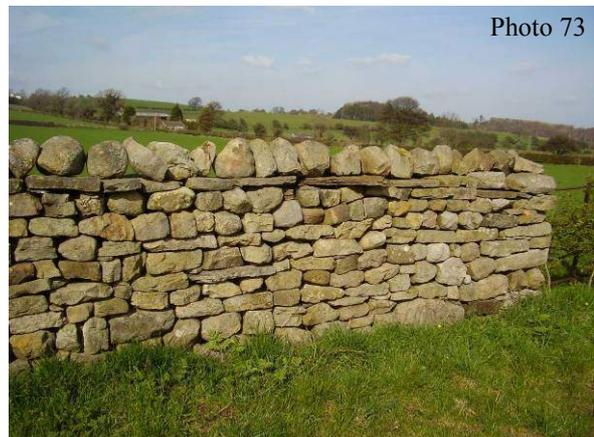
the north of the village (photos 71, 72 and 73). The substantial masonry walls lining the west side of the road opposite School Cottage (photo 74) are important in defining the character of this part of the conservation area. To the south side of the Green a short length of birds-mouth timber fencing guards the drop to the lane (photo 75) but this is out of character with much of its surroundings. There are very few examples of domestic timber fences although timber post and rail fencing has been used to divide up and maintain the boundaries of the paddocks to the north of the village (photo 76). Gates within the village are predominantly timber and vary in design. Although there is a significant amount of hedgerow around the village little exists within the conservation area.

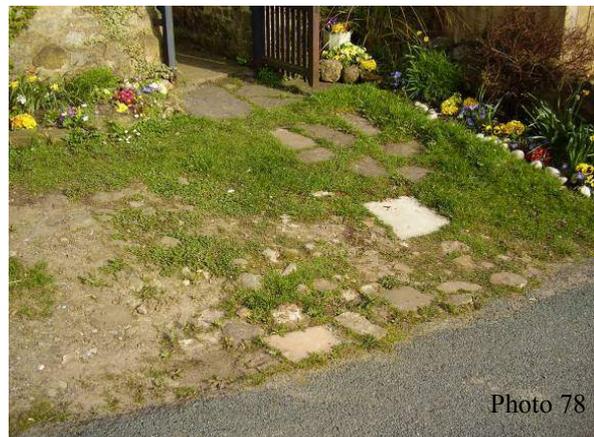
Photo 78

private drives which retain the informal earth “wheeler” tracks leading to houses or garages (photos 77). An exception is the area in front of School Cottage (photo 78) where a small section of stone flags and cobbles survive hinting at the possible past surfacing employed more widely through the village. The village pump (photo 79) has been set in a concrete base when it was restored although perhaps here a stone surface would have been more traditional. In recent times rolled gravel has

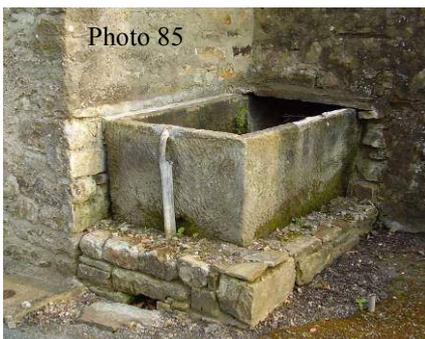
Photo 85

To the rear of the pump a litter bin has been fixed and painted to a similar colour to the pump (photo 79). It appears to be well maintained and an appropriate addition to the village green. Another historic water supply is to be found adjacent to the Manse (photo 85) where a large stone cistern built into an angle in the north wall would have served as a water supply or possibly as a horse trough but is now dry. Set on the Green is a modern commemorative bench (photos 3) placed in memory of a local lady of character who lived at The Villa. The village notice board and an informative history display are affixed to the front of the stone built bus stop.

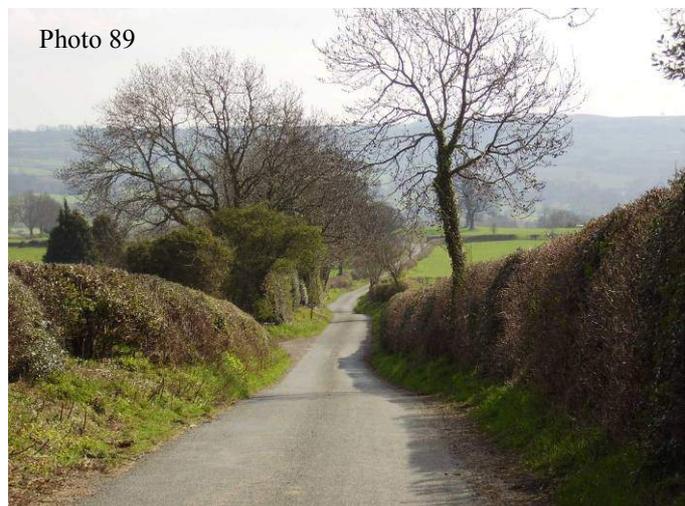
Photo 89

This approach to the village is down a long sweeping hill, set between high hedges in a sunken lane (photo 89). The impression is of an old

route or track way that has been long established in the landscape. The village is seen in glimpsed views between these hedges and over gates but from the north in general it is the roofs of the village that provide a point of foreground interest in the wider setting of the Wensleydale landscape (photo 87). The individually

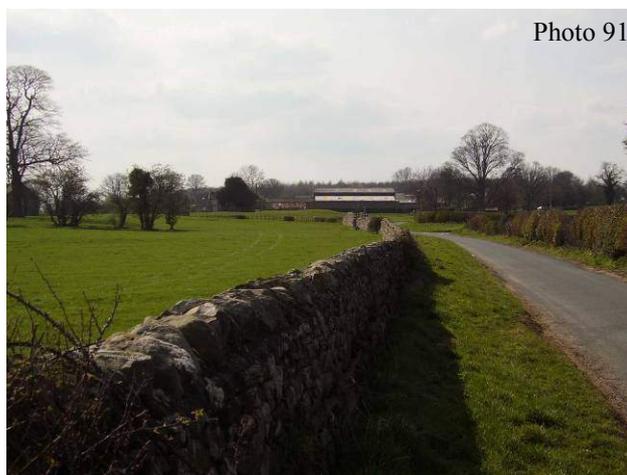
Photo 91

From the east the village remains hidden until barely ½ mile from the junction with Moor Lane, the road up Arklow Hill. When the village comes into view the first buildings are the barns sited to the rear of Plane Tree Cottage (photo 91). These large modern structures dominate the view as they appear at the point the road changes direction and are not screened from view. Notwithstanding this they are appropriate as they give a clear message that Thornton Steward is a

working agricultural settlement and not a dormitory village. The changing requirements of the agricultural industry have made this type of building necessary and as such they have become part of the landscape. Their appearance may be out of keeping with the wider conservation area but they nevertheless form an

The visitor to Thornton Steward is most likely to approach the village through this area. It is characterised by an open approach visually dominated by hedges and open fields (photo 91). The estate railings (photo 98) play a significant part in this as they allow a clear view through to the field that sits slightly elevated above the road. Beyond this important open field glimpses of the village roofs and backs of some of the properties can be gained however the most prominent buildings are the modern barns that curtail the view across the field and delineate the extent of the working farm. As the village is approached the railings give way to stone

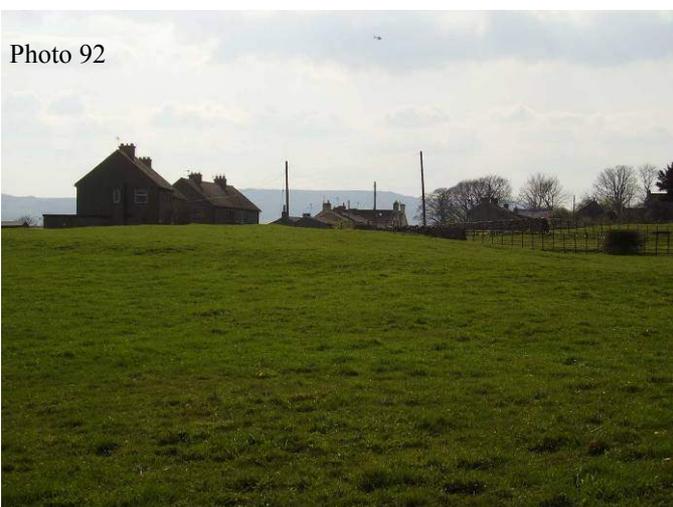
Photo 92

important and intrinsic part of the village itself. The first residential properties to be identified are 1-4 Field Side, which stand almost in isolation at the east of the village (photo 92). Other buildings are seen in the distance, but from this vantage point they are lower set and screened behind trees and hedges for the most part. Their roofs do however hint at the more historic character of the village that is to come. Of interest in this approach is the amount of undulations and

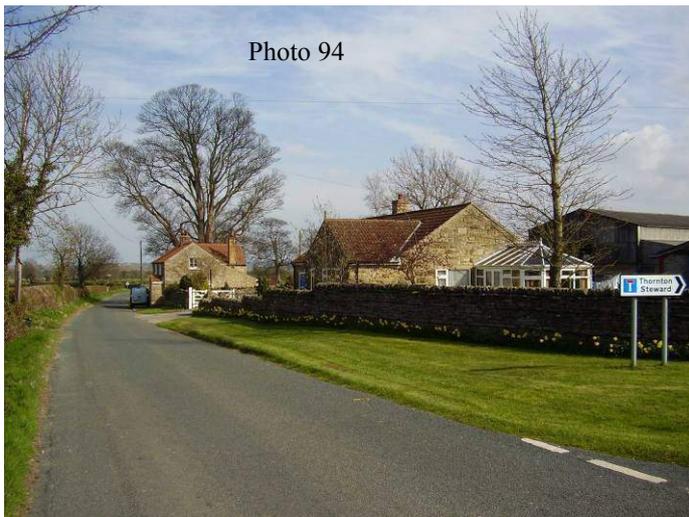
Photo 94

a backdrop to open spaces or smaller buildings and are often present in views of the village. The late 20th century bungalow on Back Lane, Urebank (photo 94), lies outside the current extent of the conservation area along with much of the active farm yard and is of a very different character to the traditional buildings in the heart of the village.

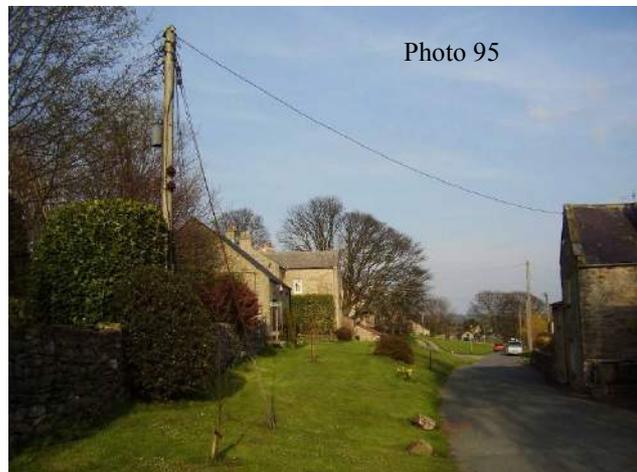
Photo 95

enjoyed of the village sitting majestically on the hillside. The first encounter with the village from this approach is over the gate adjacent to Manor House Farm where a long view down the Green takes in much of the character and sense of place that defines the Conservation Area (photo 95).

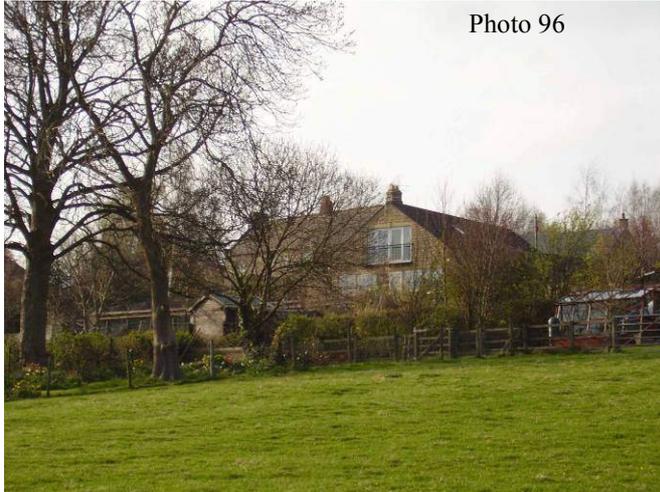
Photo 96

views of the village. Prominent in these views are some of the more modern properties (photo 96), which have taken advantage of the south facing topography with large glazed openings to benefit from the spectacular views. As the village lies more than 20 meters above the flood plain of the river Ure a steep climb is necessary up ancient sunken track ways (photo 97) flanked by archaeological evidence of the former purposes of the village including the fish ponds and the village pound.

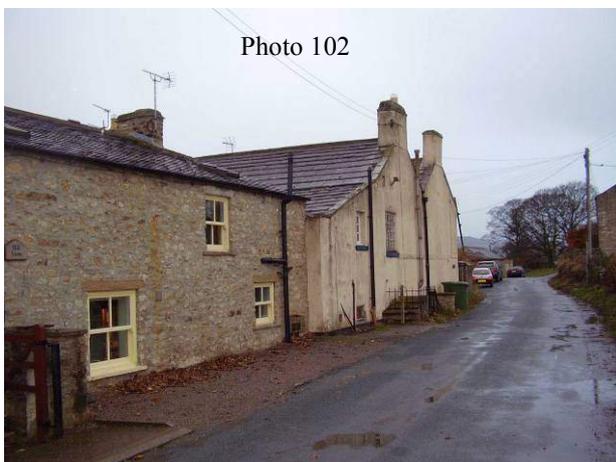
Photo 102

Moving further into the village the character of the street changes as buildings close in on both sides. This is the narrowest part of the street and views are contained by substantial stone retaining walls to the gardens of The Steps and Anvil Cottage on the north side (photo 38) and by the backs of The Old Vicarage and the ancillary buildings to the rear of Pear Tree Cottage to the south (photos 102 and 55). There is an important gap in the southern frontage where an access has been created to

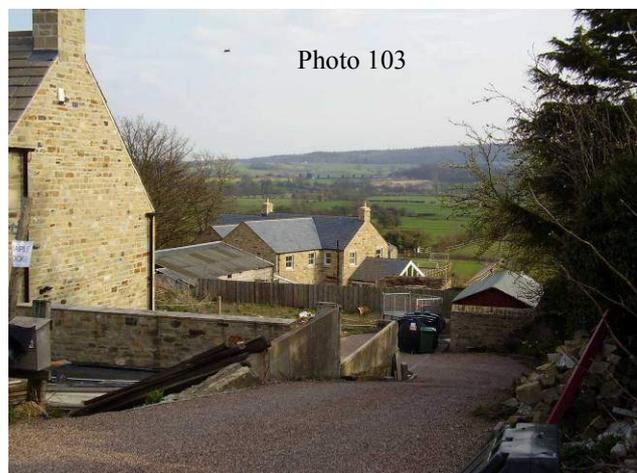
Photo 103

serve a new property, Maple Lodge, which is both set back from the road and below the level of the highway (photo 40). Although a substantial opening has been created here its impact on the enclosed character of the street is limited by the high stone wall to the Vicarage on the east and the assorted garage blocks of Pear Tree Cottage to the west. The scale of the house also helps maintain the enclosed view whilst allowing a glimpsed view to the wider scenery beyond (photo 103). Although this view

includes the wide expanse of the dale it is dominated in the foreground by the landscape treatment to Maple Lodge and by the view of the roofs of the recently built property beyond to the south. This new house is accessed from further along the village at the southern edge of The Green, sharing access arrangements with The Villa and Villa Cottage. Although currently rather intrusive in the landscape these buildings are very recent additions to the village and have not had time to weather into the scenery. They are very different in scale and form to many of the village houses however their quality of construction and selection of materials should result in them settling well into the character of the village in due course. The loss of possible open views across the site is perhaps less readily resolved however the driveway to Maple Lodge does allow a significant view to the south which should be safeguarded.

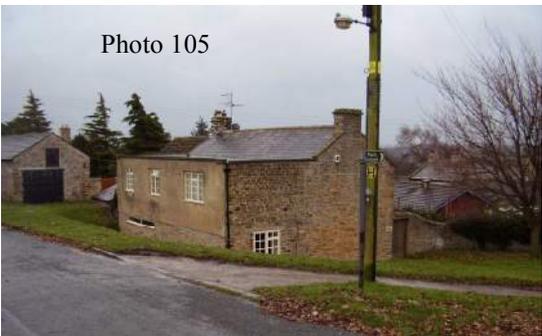
Photo 105

This building leads to the rear of Pear Tree Cottage, which is architecturally undistinguished (photo 105). The flat roofed, rendered extension to the building is located in a very prominent position in several views and does not do justice to the attractive and character-full building to which it is attached. The southern elevation of Pear Tree Cottage is a fine example of the local vernacular tradition retaining its earlier form of windows, its garden wall and slate roof (photo 18).

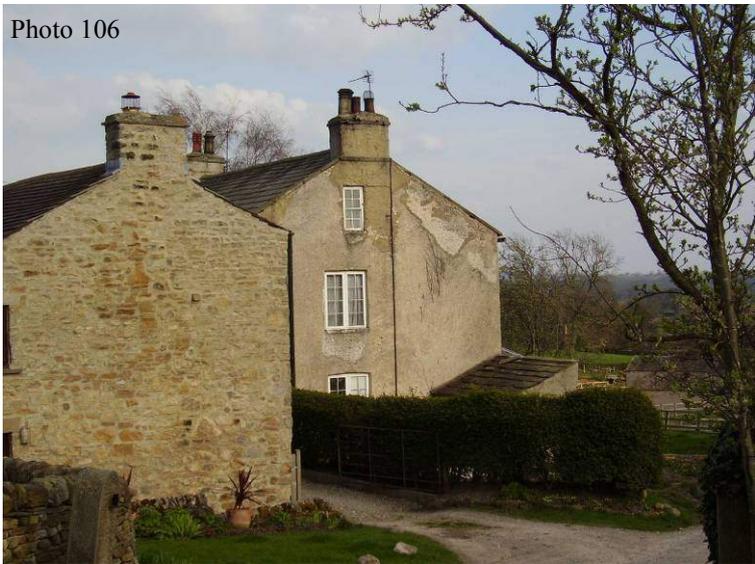
Photo 106

The Cottage also has a prominent gable to the west end, which forms an important termination feature in views across the Green (photo 106). Directly to the south of Pear Tree Cottage is a small group of very varied properties (photo 34), Woodcote, Villa Cottage, The Villa and The Lodge. Stylistically Woodcote dates from the 1970's and is a compact bungalow with a prominent timber clad gable. In style, form and material it is completely at different from its neighbours. Notwithstanding this its presence is discrete and the surrounding stone wall and fine gates do much to help it assimilate to its setting. Villa Cottage (photo 20) is of the local vernacular being similar in form to several of the more modest older established properties that line the Green. The Villa (photo 26) is a substantial house built in the late Georgian style but thought to date from the 1830's. Although a building of importance it makes little contribution to the character of the conservation area due to its secluded position, indeed the main view of the house from the village is of the rendered west gable sitting above the surrounding hedge (photo 106). Also discrete in its presence is The

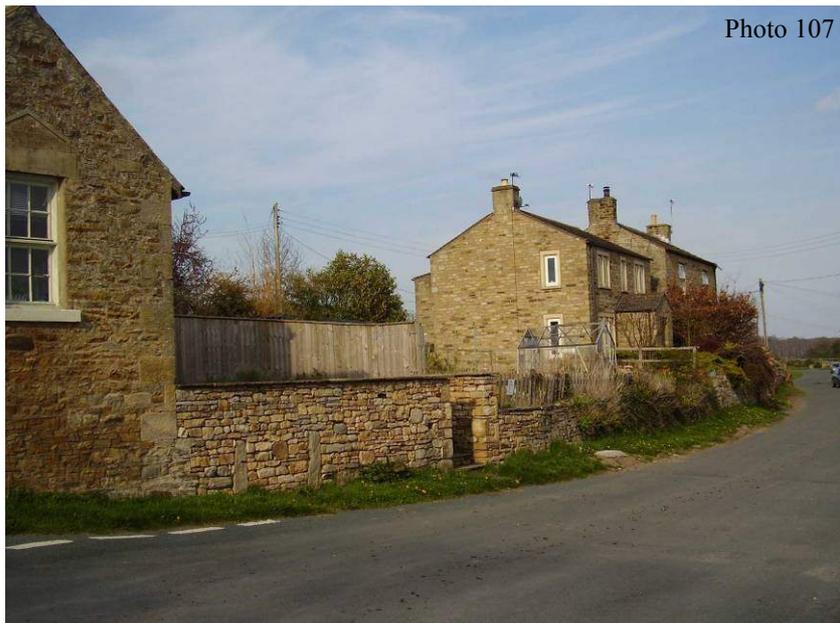
Photo 107

ties it to the immediate area, making it truly a "local" school. Between the school and Anvil Cottage is an area of open land (photo 107).

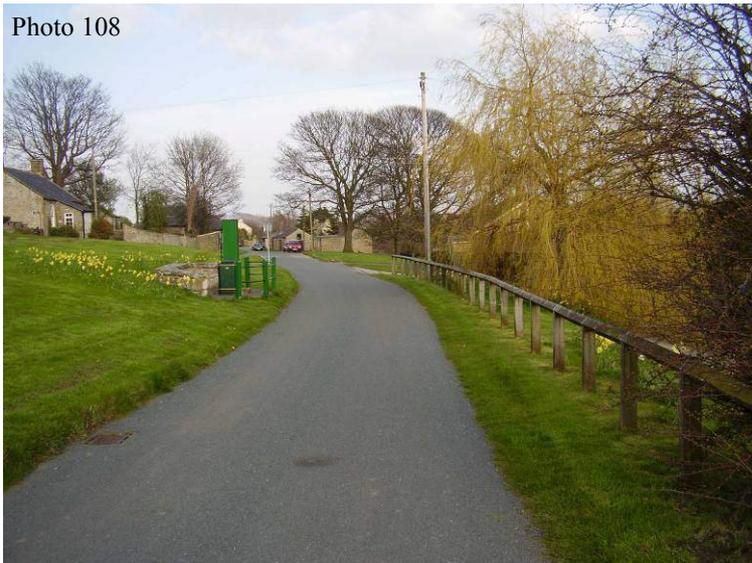
Photo 108

In Thornton Steward the Green has the individual character of being set on a marked slope in the land making the properties on the north side of the green substantially higher than those on the south (photo 108). The result is that whilst the houses to the north face out over the public space from a commanding position, most of those to the south turn their backs to the space to benefit from the spectacular views over Wensleydale. The extent of The Green is defined at

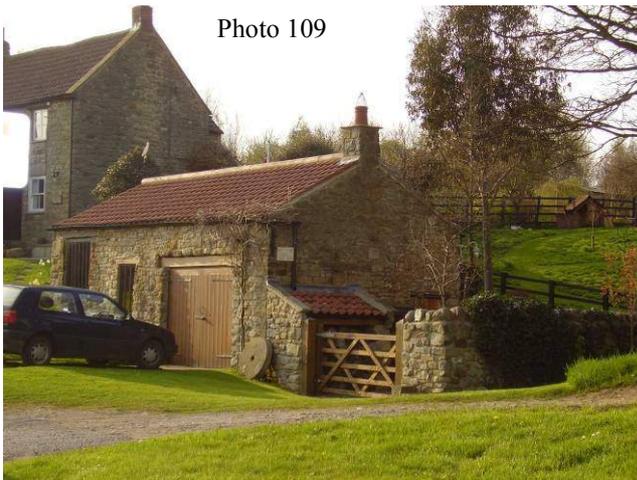
Photo 109

Looking in detail to the north side first, the properties between Fort Horn and Birch Gill Manor represent an excellent group of varied vernacular properties (photos 49, 62, 67 and 109). The cottages and incidental buildings are almost exclusively stone built with the exception of Dale View, which is rendered. There is a variety of size and style within these buildings, however they are all constructed to a similar scale, larger buildings being created by the extension of a single

property. In this part of the village the smaller sheds and outbuildings make an important contribution to the character of the village (photos 61, 109 and 111), as do the numerous accesses and tracks across

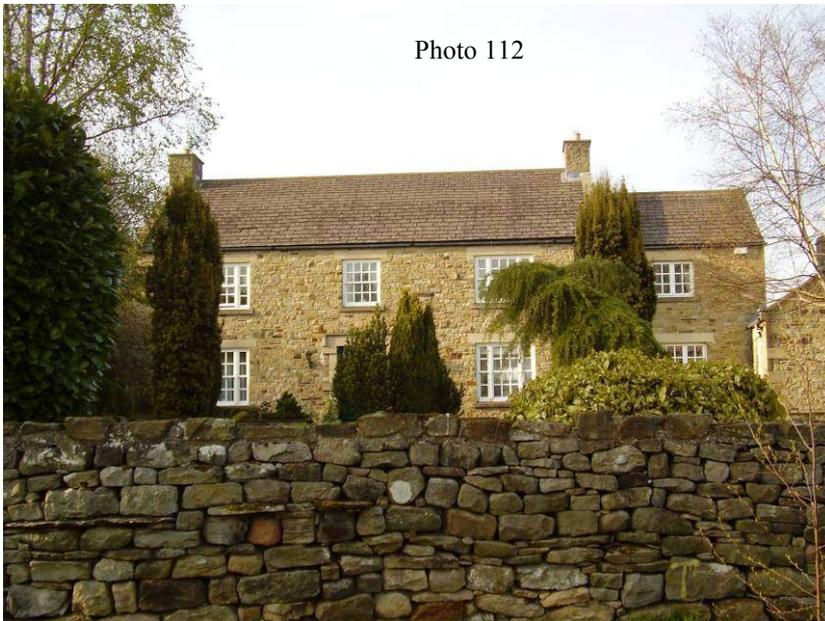
Photo 112

The two buildings that define the ends of the north side of the Green differ from the established pattern. At the west end the 20th century Birch Gill Manor is a well proportioned substantial house set back privately in its own grounds (photo 112). An architecturally polite building it does not contribute greatly to the character of the conservation area, as it is set well back from the front of its site and thus does not feature in most views through the village. The surrounding trees and stone wall provide a secluded setting and contribute more to the character of the conservation area than the house itself. At the east end of the Green Fort Horn (photo 9) is a complete contrast to Birch Gill and to all other buildings in the village. Although it stands well back from the Green across its raised garden the scale of the central tower makes a marked contribution to the appearance of the village and provides a punctuation to the established roof lines. The height of the tower is exacerbated by the use of single storey wings to flank it and by the strong vertical emphasis of the canted bays and tripartite Venetian windows. The modern bungalow to the left hand side rather diminishes the visual impact of the historic building but to some extent balances the older ancillary buildings to the right.

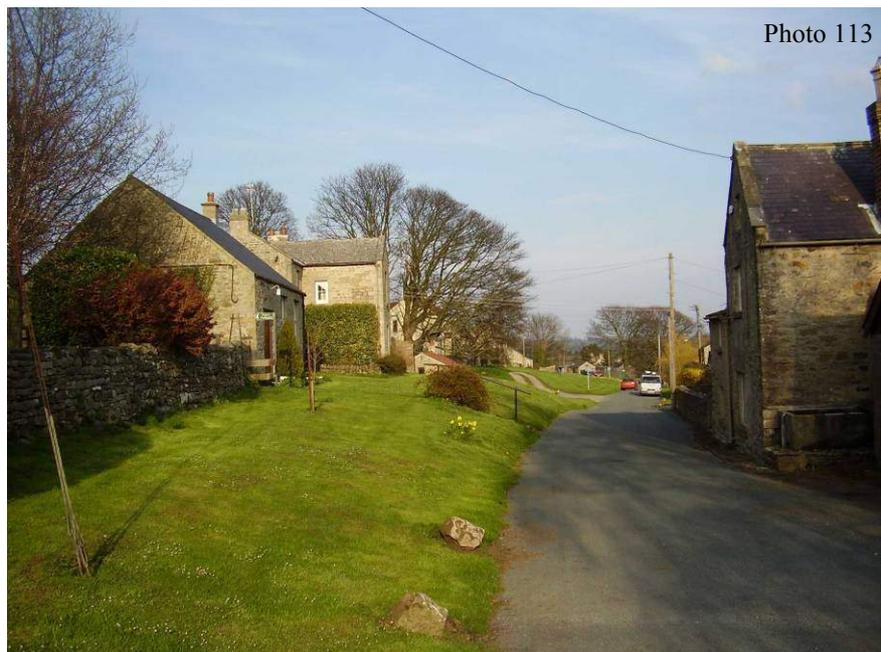
Photo 113

Manor House (photo 63) and The Manse (photo 54) define the line of the view (photo 113), although the back of the Manor House is rather detached from the main part of the village and the house itself contributes little to the wider character of the conservation area (photo 114). The Manse is seen as the terminating building in most views along the Green, its substantial bulk being set against a backdrop of trees and broken up to some extent by its surrounding outbuildings and walls (photo

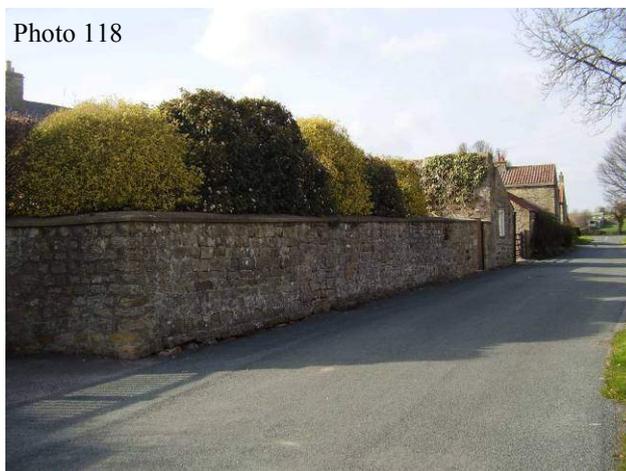
of Old Hall Farm (photo 118). Here the building, of great interest in its own right, makes very little contribution to the character of the conservation area being shut away privately behind a high masonry wall and substantial gates. Facing Fort Horn's garden wall are the Old School (photo 64) and School Cottage (photo 46). In this context these two properties appear huddled together with several smaller incidental buildings but retaining glimpsed views through to the wider village. Their small scale helps create an intimate feel to this part of the village. Ash Tree House and Thornberry directly to the north of School Cottage are modern houses completed in 2005 in a natural stone finish (photo 37). Their scale and proportion differentiate them from local vernacular buildings and from new construction in the local tradition such as Anvil Cottage (photo 38). They are uncompromisingly modern properties however the use of natural materials helps assimilate them in the conservation area and their careful positioning, back from the road side behind traditional low stone walls reduces their impact in wider views.

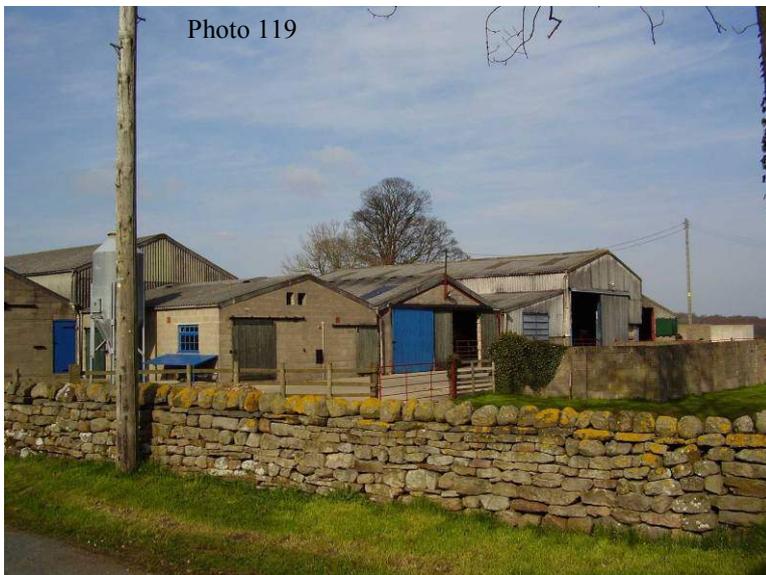
Photo 119

Adjacent to Thornberry but outside of the conservation area boundary is the active farmyard that dominates some views of the conservation area (photo 119). The scale of its buildings and the wide access to the open yard are very much out of character with the smaller scale and more intimate spaces of the village. Despite this the farm buildings make a contribution to the setting of the conservation area in that they often provide

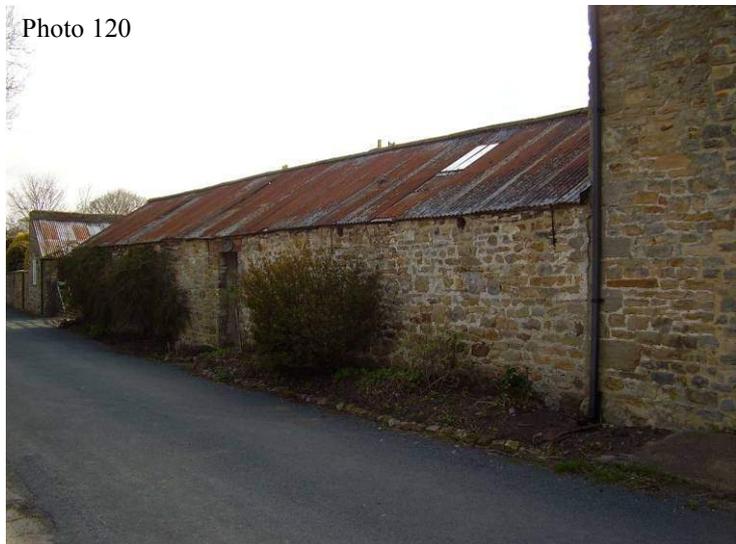
Photo 120

On the west side of the street several of the buildings that formed the historic farm yard have now been converted to residential use, in all cases successfully. The Old Stables (photo 45) do not impact greatly on the conservation area being set behind a smaller outbuilding on the road edge, but The Round House (photo 44 and its attached barn (photo 120) continue the back of pavement
