THORNTON STEWARD

CONSERVATION AREA APPRAISAL AND MANAGEMENT PLAN

Adopted as Supplementary
guidance on 24th February
2009

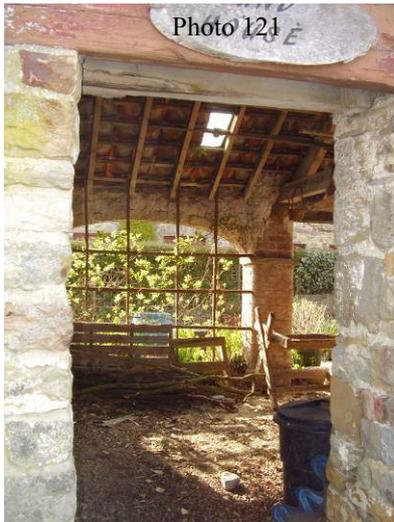
Photo 121

development of solid masonry walls established with Fort Horn and The Old Hall. There are limited openings to the wall on the road side and glimpses through the gate to the Old Stables reveals a traditionally proportioned farmyard (photo 121) . Of note is the barn running at right angles to the road (photo 122), which exhibits clear evidence of a number of changes in use possibly having started life as a coach house to the Old Hall. The final property on this side of the street (photo 123) creates

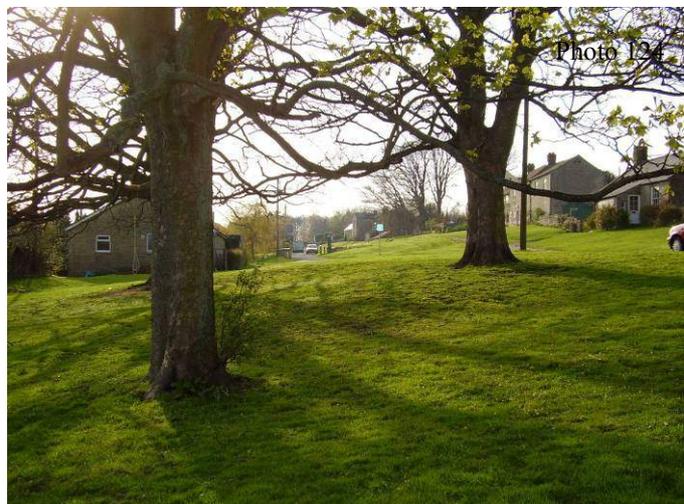
Photo 124

Within the conservation area there are two principal open spaces of note, the village Green (photo 124) and the field at the east end of the village . The village Green is clearly the more important of the two and providing a focus for events, monuments and village life. Visually it is defined by the range of properties that flank it to the north and south, but an important characteristic is its sloping topography and the relative heights of the buildings around it. Crossed

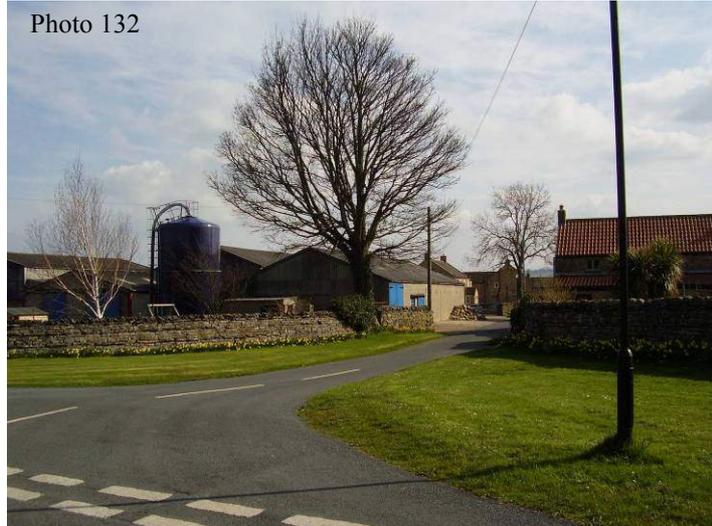
Photo 132

The final selection of trees worthy of note lie along the street from The Green to Back Lane. Here the Ash tree in the garden of Thornberry (photo 37) and the large specimen to the west of Urebank (photo 132) are important elements in views down this lane whilst the small tree in the hedge at the top of the lane provides an important termination point to views up hill (photo 117). The first of these trees is protected by a
